What's happening at the East Church ?

Laing Traditional Masonry Limited are the contractors who are repairing and restoring the church, and Andrew Newcombe (pictured left) is Site Manager.

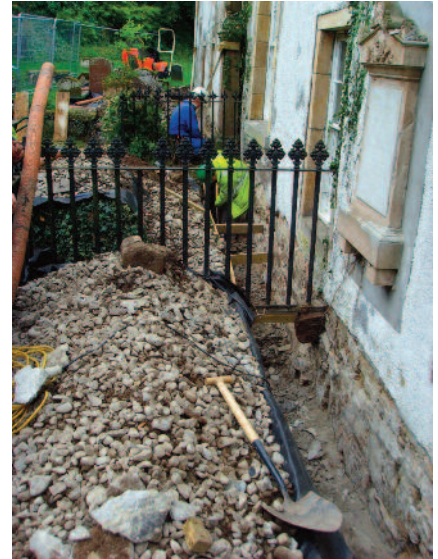
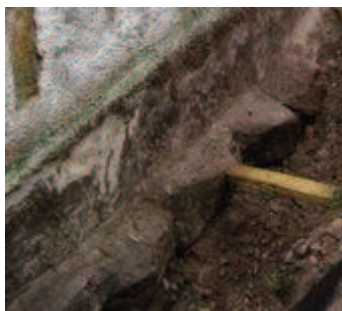
The 1970s drainage ditches have been re-opened and the old pipework removed. The previous attempt to seal the base of the building with cement and bitumous outer coating didn't work - and in fact sealed water inside the church.

The old coating and bottom metre of cement harling has been chipped off, and a new breathable lime coating used to line the drainage channel before putting in new pipework.

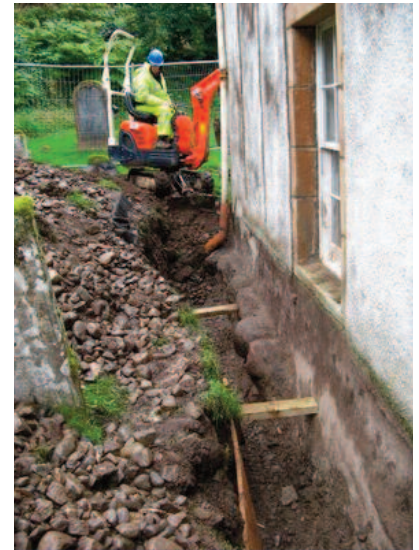
opening up south wall drainage trench: photo by John Wood

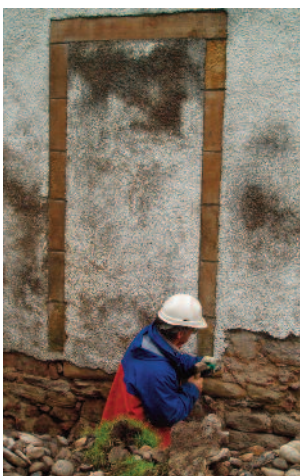
Paddy removing harling by earlier south wall door opening. This would have led to the west loft

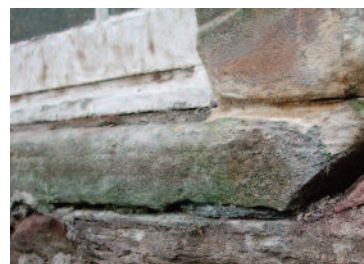
slate pinning used below window sill

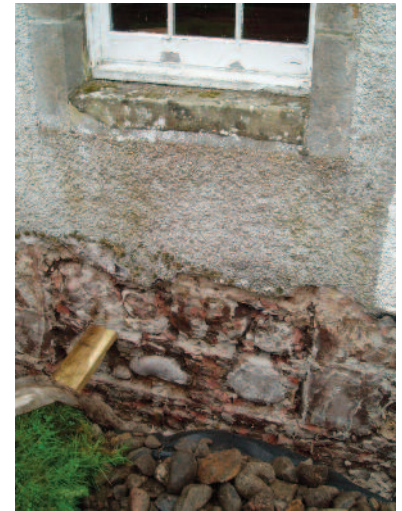
. . . confirmed written accounts – by revealing the base of the door that led to the north aisle loft

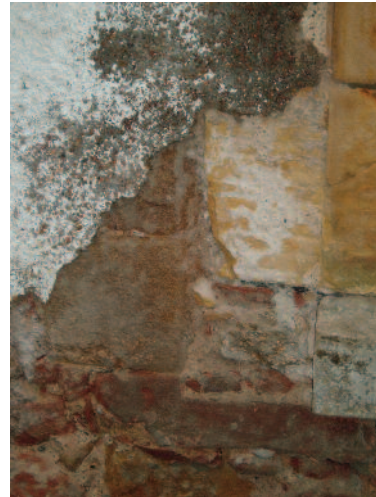
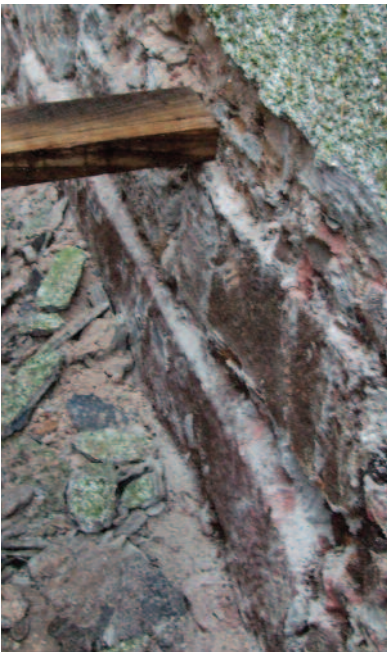
. . . why are these large flat dressed stones in the foundations, and where did they come from?

In the south wall 3 stones laid end to end measure more than 3 metres in total. In the north wall two stones – one of 1.6 metres – are placed on top of each other.
