CROMARTY EAST CHURCH

Painted Armorial Panels Conservation Treatment Report

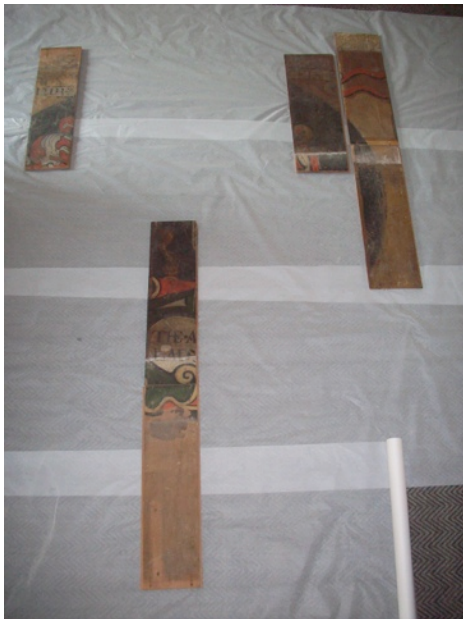
Now that the pieces have been cleaned and treated, we have made several observations which alter some of the statements in our initial assessment report. For instance, in the case of Lady Anna's arms, we discovered that one of the unlocated panels in fact forms part of the lower frame of the text (see Figure 1). This panel is not illustrated on Scott's 1968 reconstruction drawing.

Figure 1: known locations of Lady Anna's armorial painted panels.

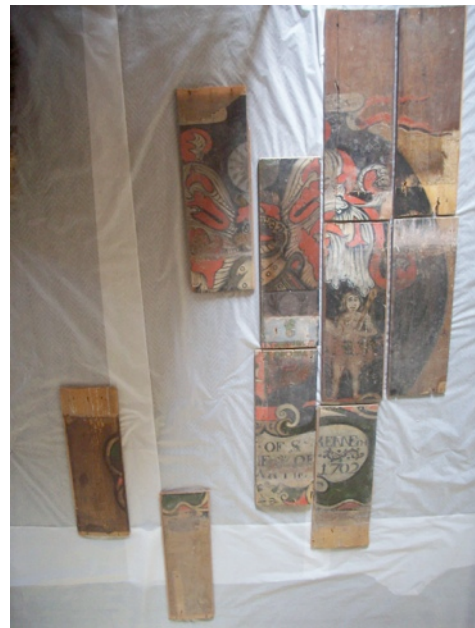
Figure 2: known locations of Sir Kenneth's armorial painted panels.

The arms of Sir Kenneth remain as illustrated by Scott (see Figure 2). A further painted panel with a sunburst remains unlocated. It is painted in a similar style to the arms, and may be associated with them in some way, however its location cannot be determined. The sun motif is also visible on the pews, however these in situ panels are painted in a different style from the arms (see Figures 3, 4).

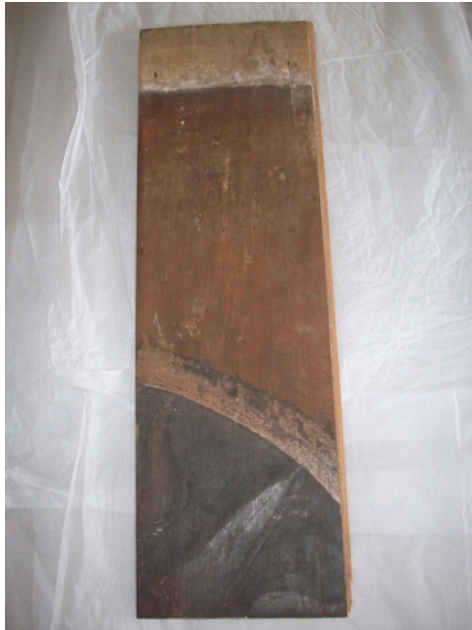
Figure 3: panel with sunburst, unlocated

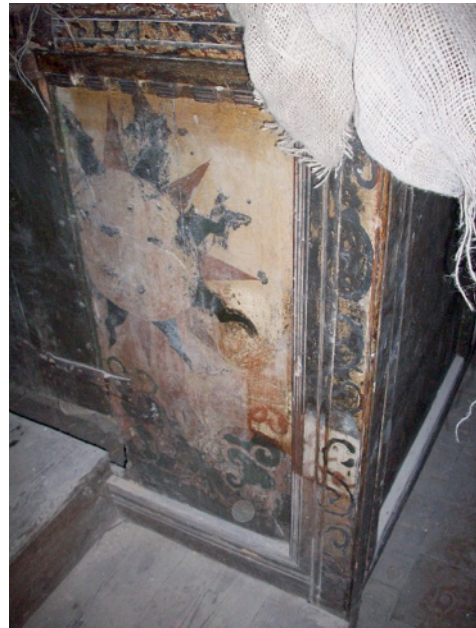
Figure 4: pew panel with sunburst – different painting style

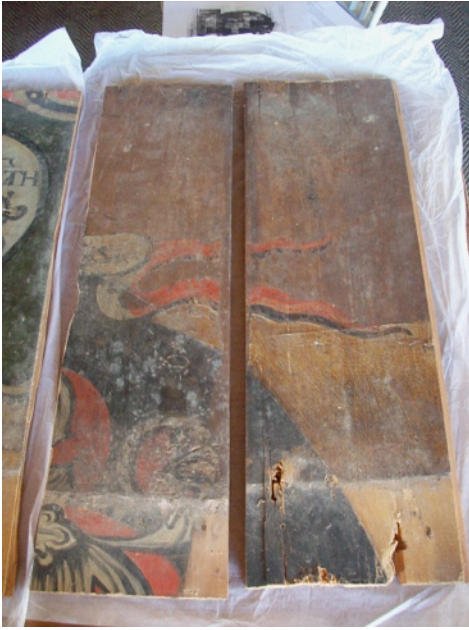
Previously we had assumed that the tongue and groove jointing of the panels was part of their original construction. However, the joints do not correspond if one tries to re-assemble the panels (see Figure 5), and it soon became clear that these joints belong to the time when the arms were broken into smaller pieces and used as part of the pews. Originally the arms would have been made of quite large panels, probably about double their present width, and occasionally one may see the original joints, which were birdsmouth rather than tongue and groove. Each panel probably ran the entire height of the armorial plaque.

Figure 5: two non-corresponding grooved joints rather than a tongue and a groove.

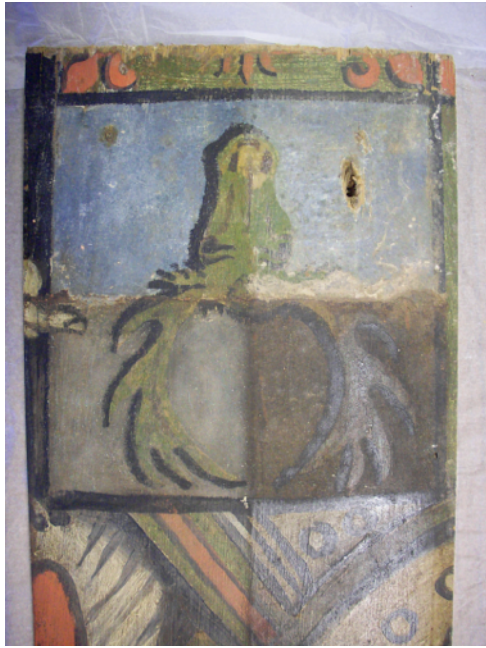
Figure 6: during the cleaning process

All 37 painted panels (including those without any design), were cleaned. This involved removing surface dirt. Not all the panels had a varnish coating, but where present this was also removed (see Figures 6-9).

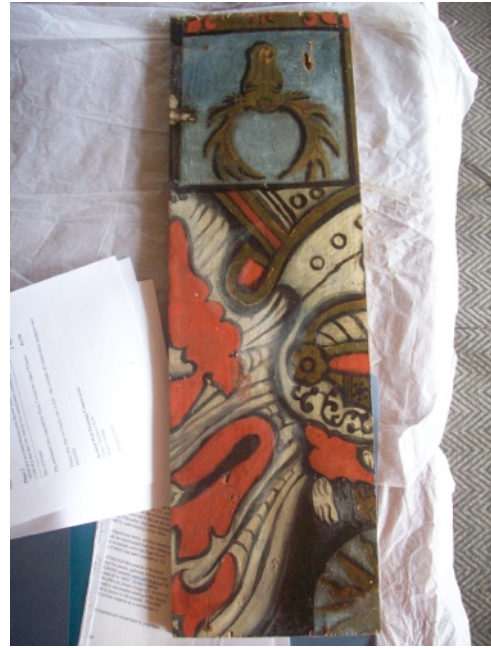
Figure 7: after the cleaning process

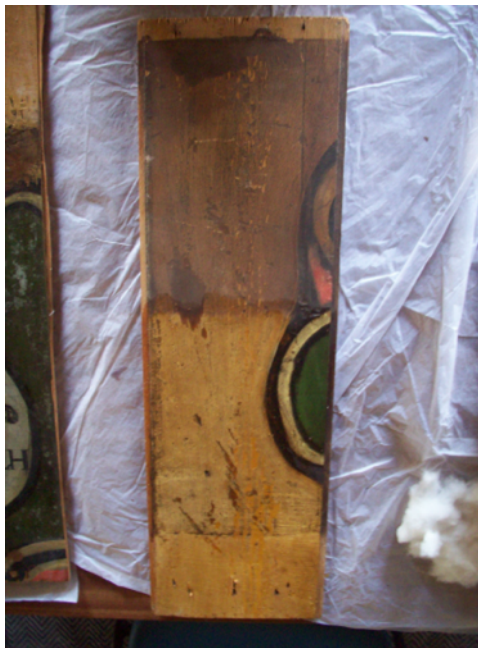
Figure 8: during the cleaning process

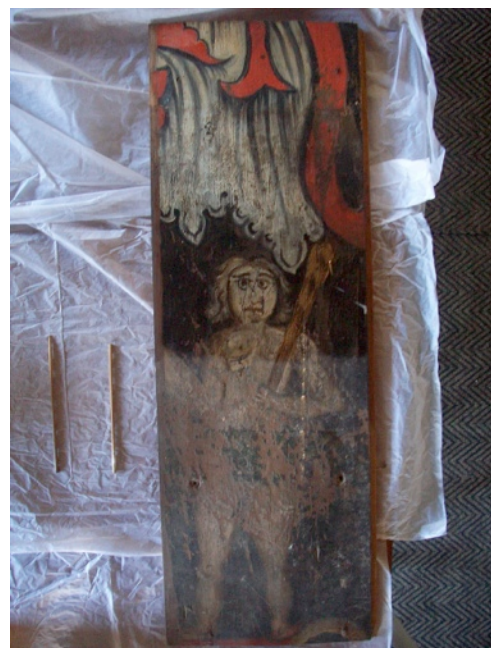
Figure 9: during the cleaning process

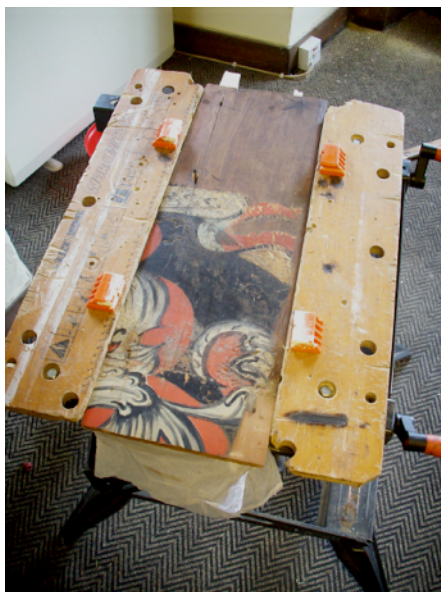
Figure 10: split panel glued and clamped to set

Two of the panels were broken and required re-alignment. One had split and the other had separated into two pieces. The latter was set back together by inserting dowels and applying adhesive along the join, then clamping in place until set. The former was simply glued together then clamped until set (see Figure 10).
