Cromarty East Church Ross and Cromarty

Archaeological Survey and Excavation 2008-2009

Report No.	HAS100102
Project	HAS-CEC08-9
Client	Scottish Redundant Churches Trust
Planning Ref	N/A
Date revised	24 July 2010
Author	John Wood

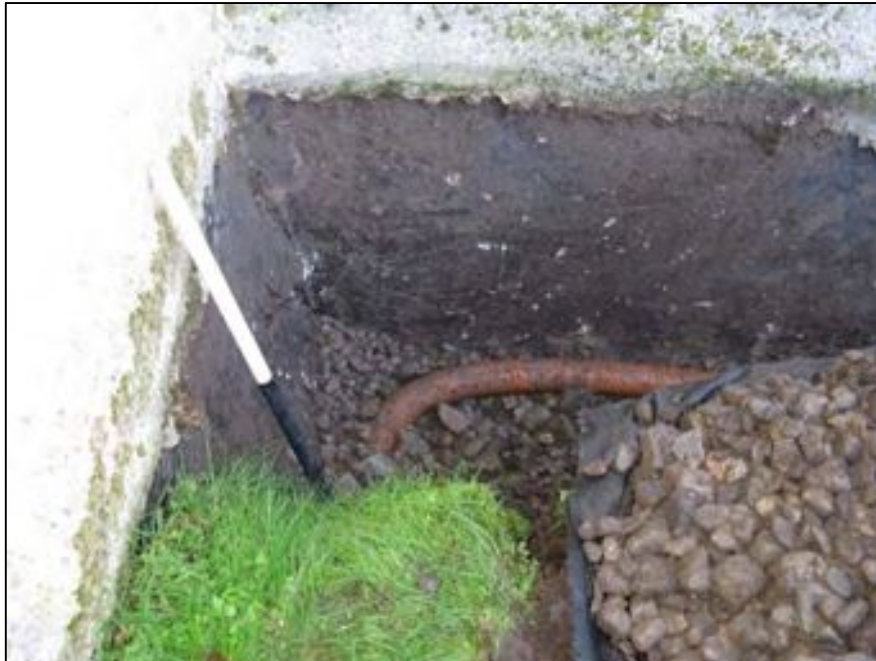
Plate 1 Corner of E wall and E porch, by door, showing bitumen, cement harl and perforated pipe drainage as found

Initial investigations in 2007 confirmed suspicions that the repairs undertaken in the late 1970s had unfortunately contributed to the damp problems they were meant to alleviate. The outside of the church had been coated in waterproof, cement harl, and the foundations coated in bitumen, but a French drain laid around the walls was not functioning properly and – as it turned out – was retaining water underneath the walls which was then rising inside. At the wall-head too, water was running down behind the harling. In the unheated building, and without a way for the fabric to breathe, the water could not escape.

The current programme of works has included replacing the drains and reharling the walls with lime, re-roofing and selective internal re-plastering. A reinforced concrete raft has also been laid within the church which incorporates a damp-proof membrane.

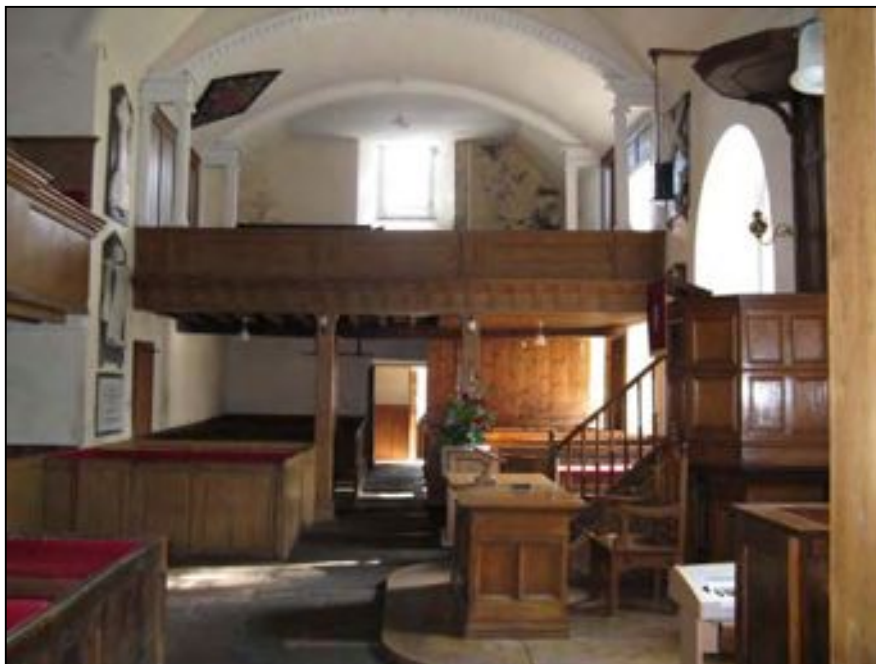
Plate 2 Interior before project started: damp in east gable

A digital photographic record was made of the building and site conditions at the outset of the works. Photography was entirely digital, using for the most part a Pentax Ist-DS SLR at 6.1 mpx. This demonstrated and recorded the poor condition of the fabric and extensive water penetration (See cover and Plate 2).

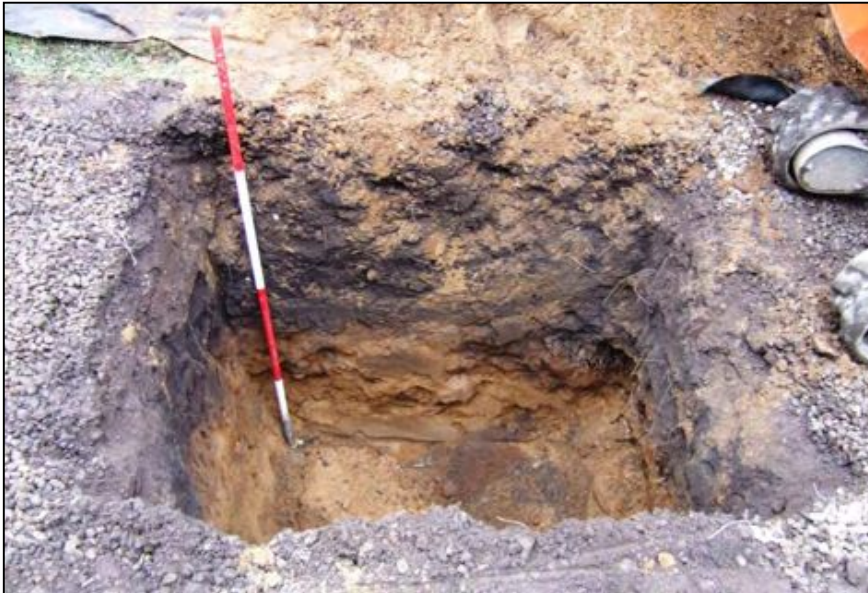
Plate 3 Soakaway in churchyard

drain and the excavation of soakaways within the churchyard. The soakaways were carefully located within existing paths and did not encounter any burials or archaeological features or finds (Plate 3).

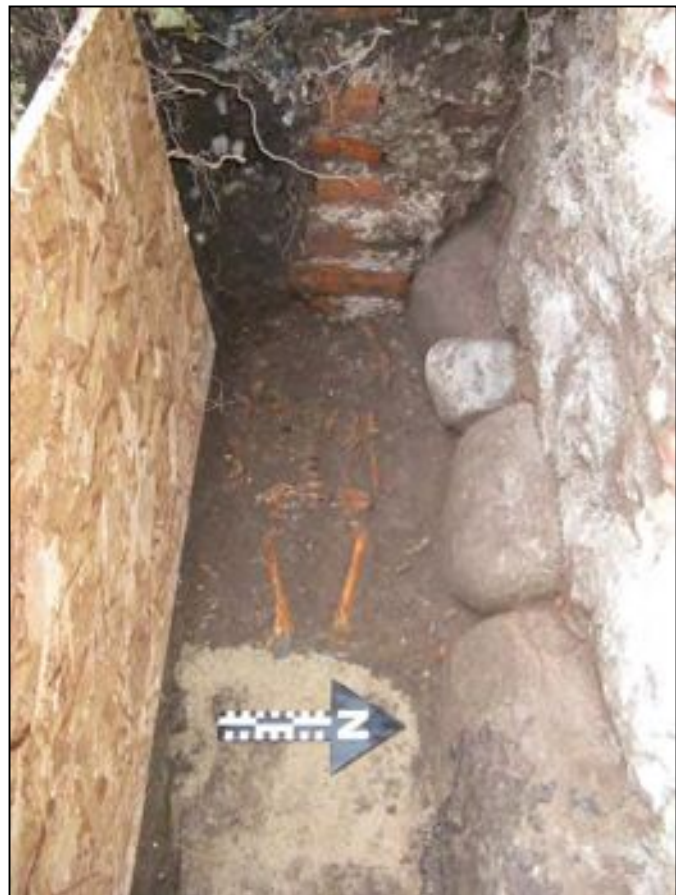
Plate 4 burial in drainage trench: centre of S wall
11

The external drainage work required the re-opening of the French drain installed in the 1970s. In the centre of the south wall this was found to have cut down onto a truncated burial, which was photographed and lifted for analysis (plate 4).

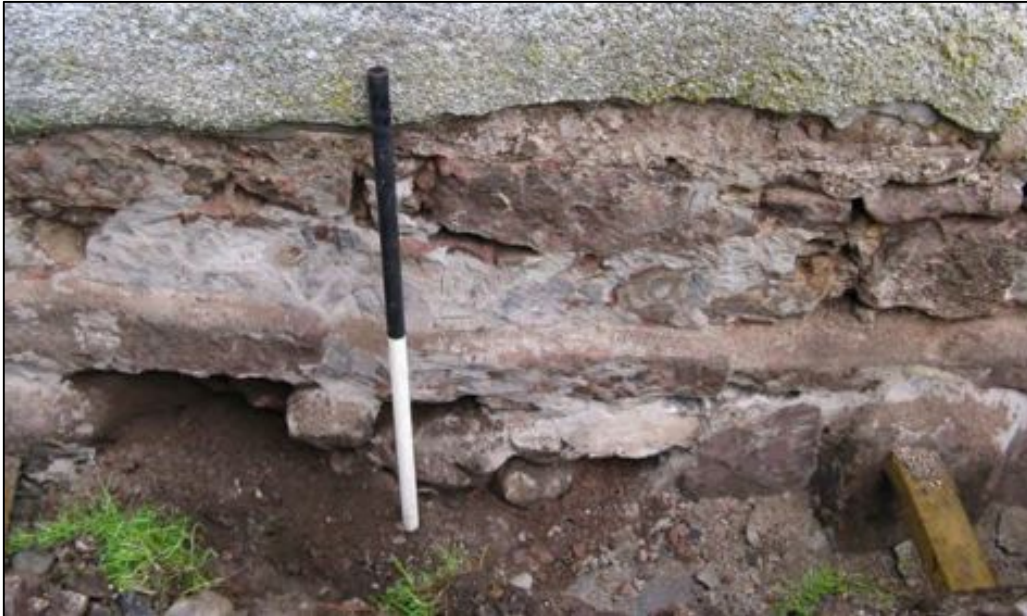
Plate 5 Dressed flat slabs reused in foundations: south wall of west aisle

The foundations revealed during the watching brief on external drainage works were found to be typical of those found in other traditional local buildings, with the walls based on large rounded boulders. There were however two exceptions to this. In the west end of the church the foundations in the opposite north and south walls were made up of large, finely dressed flat slabs with the edges carefully worked. These were clearly re-used (Plates 5 and 6

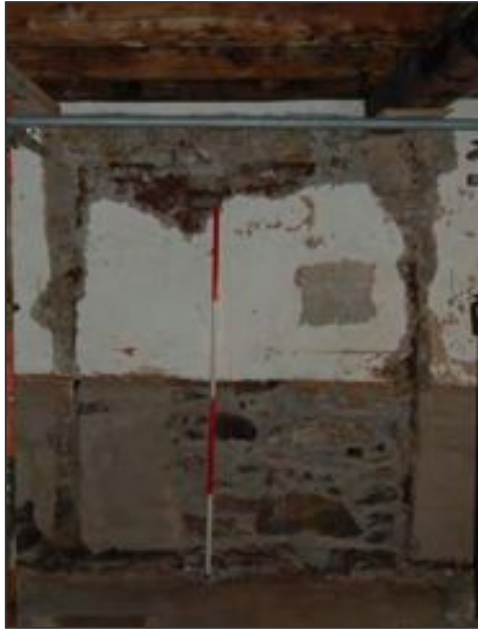
Plate 7 Blocked doorway (interior view)

wall at least, they formed the base of a (now blocked) doorway (See Figure 3 and plate 7

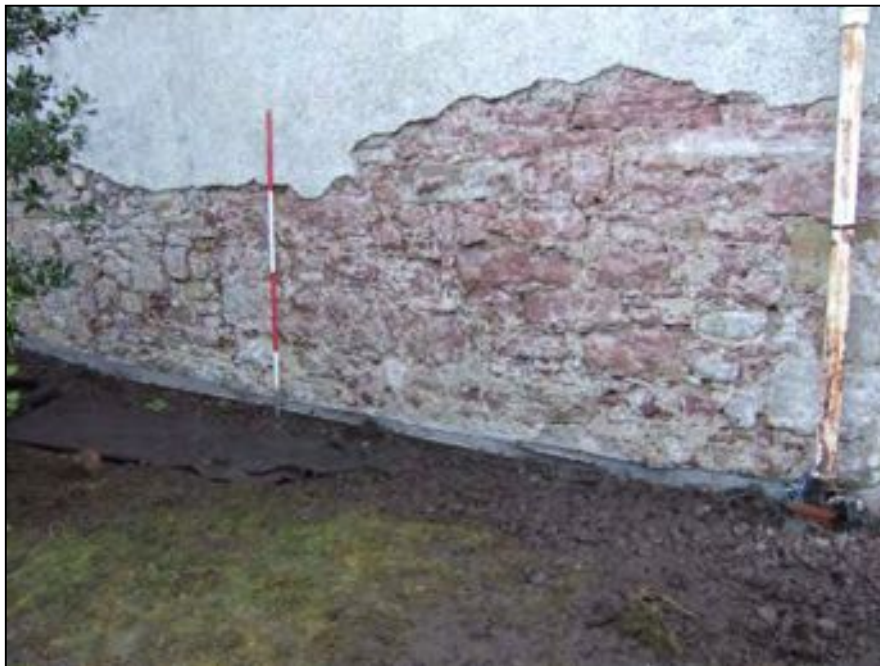
Plate 8 Blocked doorway opening visible in N wall of W aisle

The doorway was capped by a single sandstone lintel that had been seriously damaged by the insertion of timbers to support the western loft. There was no dating evidence. The doorway could only be seen as an irregular crack in the masonry on the outside as the dressed quoins had all been removed (Plate 8).

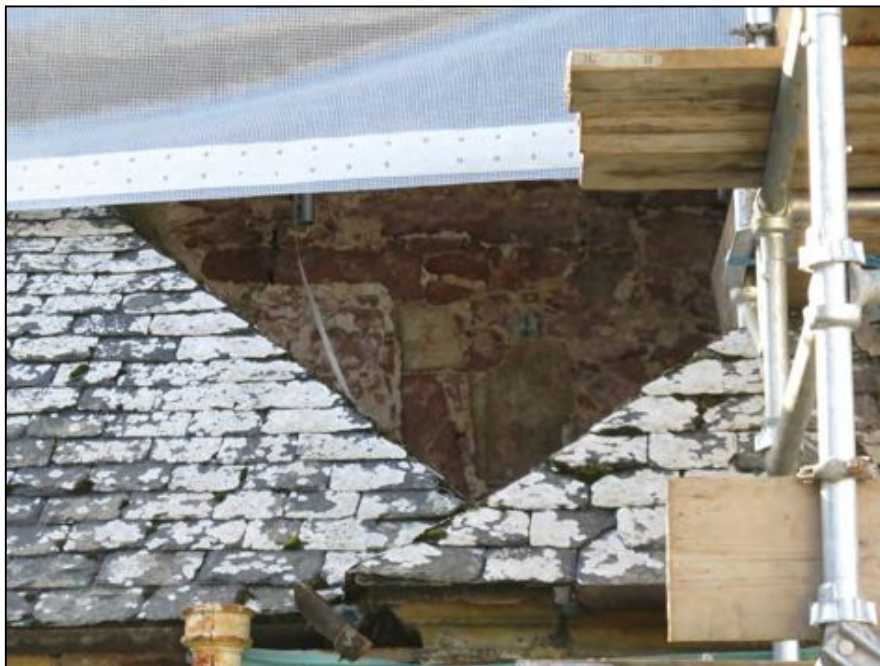
Plate 10 Evidence of blocked 16th c. window in E gable, largely hidden by E porch and vestry

In the east wall, the outline of a 16th century window could be seen on the outside above the east porch and vestry. Unfortunately this was very difficult to photograph successfully (Plate 10 above). A red sandstone lintel from a similar window was found forming the cill of the easternmost blocked doorway in the south wall (Plate 12). These offer a possible indication of the fenestration and character of the church before the 18th c. changes that gave it its present appearance.

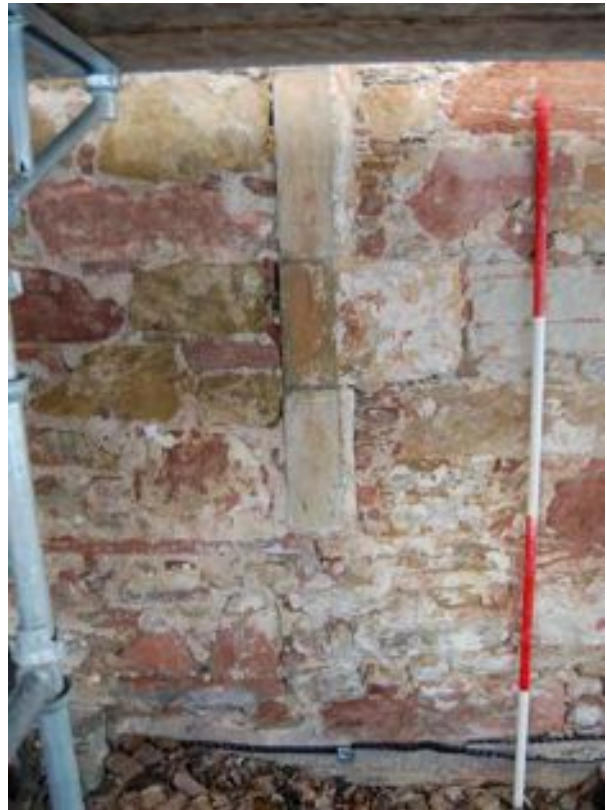
Plate 12 Reused lintel

Although little seems to have changed in the church fabric in the late 16th or early 17th c., the walls may have been substantially refashioned at some point. When the church roof was renewed in 1756, the old timbers were described as '140 years old'. Perhaps there was a major rebuilding in the early 17th c. Certainly, the wall fabric as a whole shows little evidence of alterations or rebuilds before the 18th c. Apart from the 16th c. east window, blocked late medieval window openings were not found when the harling was removed as might have been expected, although, as indicated above, a 16th c. lintel had been re-used in the south wall.

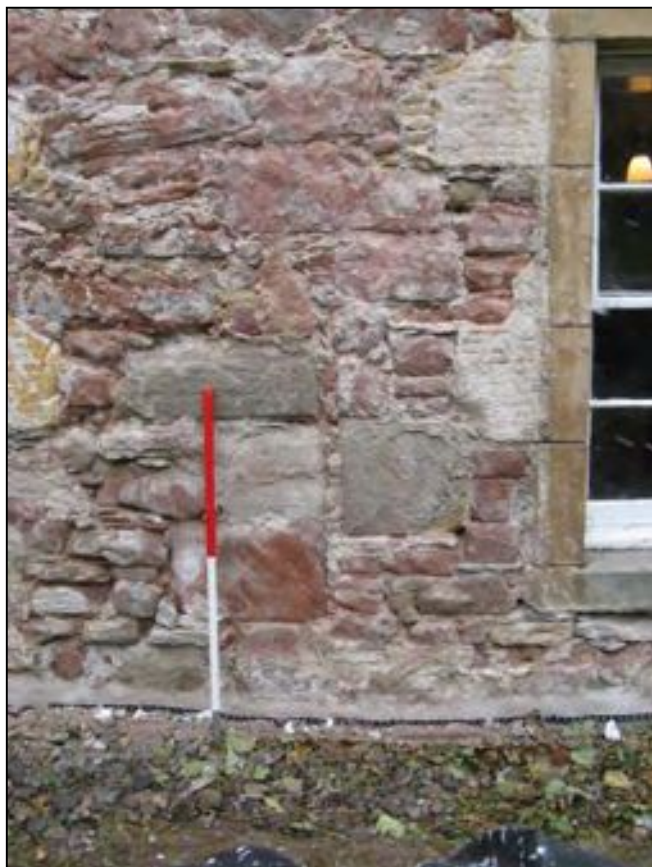
Plate 13 Quoins in S wall, approximately opposite corner of N aisle

In the south wall, a vertical line of very substantial dressed quoins could be seen, representing either a wall corner or a substantial former opening (Plate 13). This is located approximately where a nave / chancel division might have occurred before the Reformation. However, here as elsewhere, later changes in the wall fabric have removed most of the evidence leaving only a fragment.

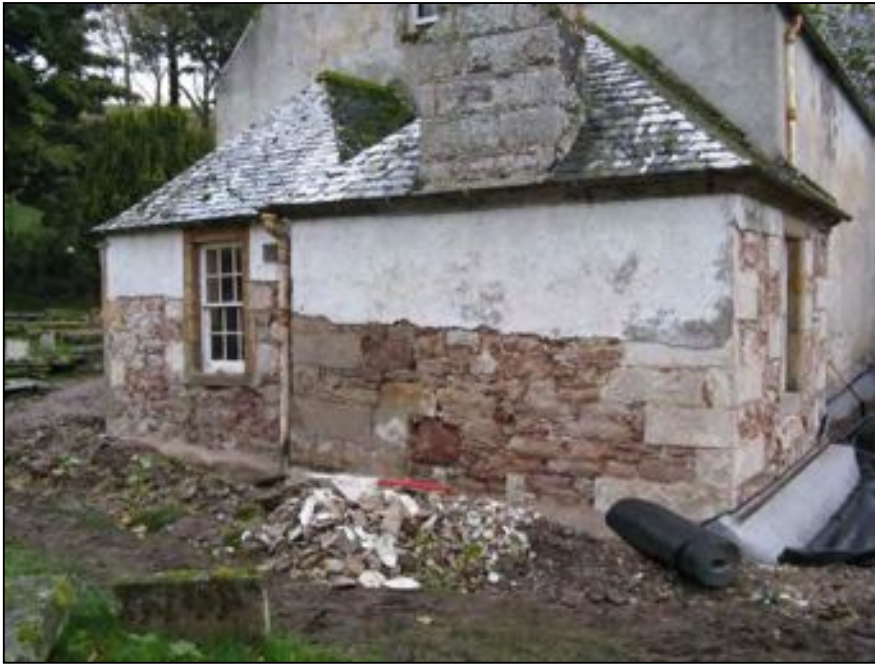
Plate 14 Vestry

Removal of the harl from the vestry showed its adaptation from the burial enclosure, including re-used grey dressed stone infilled with rough red sandstone rubble (Plate 14).

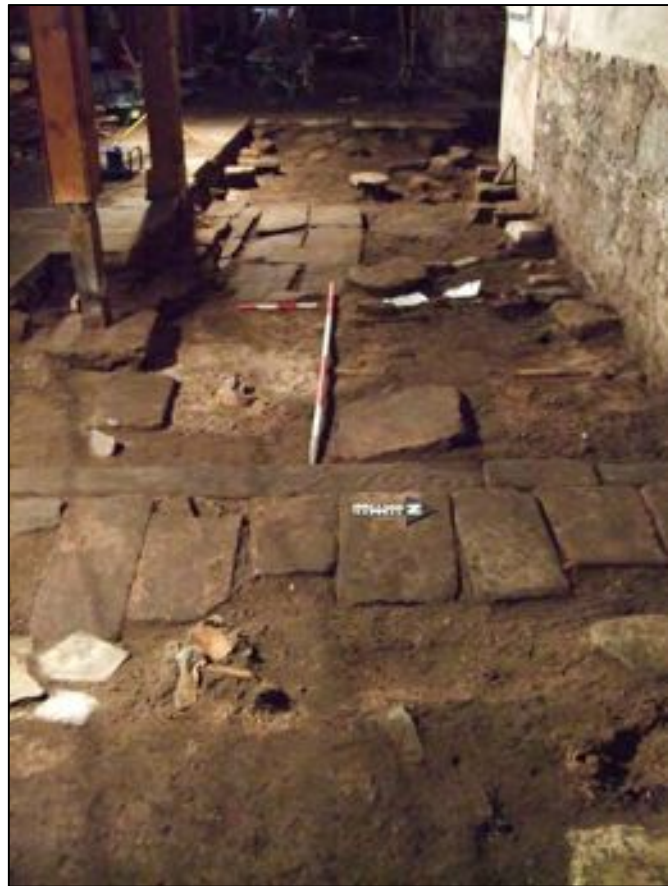
Plate 20 East aisle from E, after initial clean.

The most significant discovery was at the east end of the church where an altar kerb had been formed from re-used and cut down dressed stones (Figure 7, plates 20-21). The southern half of this feature could not be investigated as it remained covered by the concrete laid in the late 1970s, but it was clear that the centre of this kerb comprised a carved, late medieval sandstone gravestone which had been carefully cut lengthways and the two halves laid end-to-end.

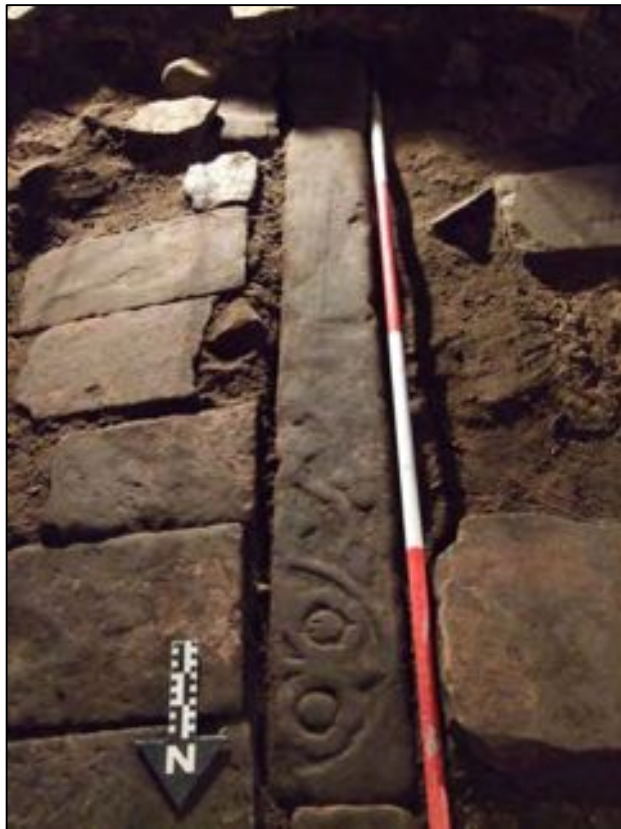
Plate 21 Carved stone, from N, showing wear

The stone measures 1750mm long, 950mm wide and 110mm thick. It was not lifted, so only the upper surface could be inspected. It was very worn in the centre, less so towards the centre line of the church. It appears to represent wear that occurred while it lay in its present position rather than at some earlier location.
