# East Church – 15 June 2010

## Removing unwanted bulges

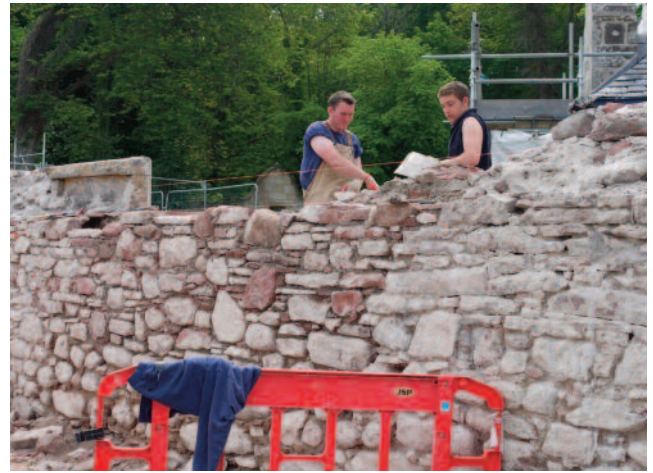
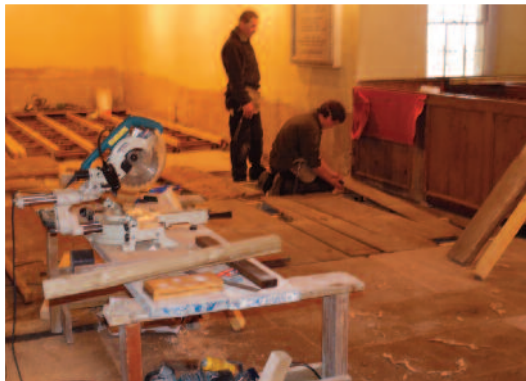
Winter frosts and many years of saturation had not only destroyed the new harling, but had also produced some nasty bulges in the wall.

The simple answer – take the sections down and rebuild them nice and straight and with plenty of new mortar. And that is just what Andrew and Craig of Laing Traditional Masonry are doing. They've also been tipping large numbers of wheelbarrows of lime mortar inside the wall to fill the voids left as the old clay mortar crumbled. The wall should be stronger than it has been in quite some time.

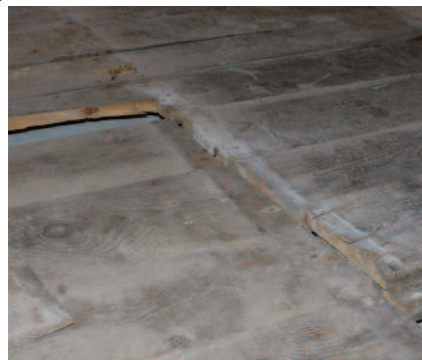
Interestingly, one section of broad old planking resting on oak supports was found under the table pew opposite and to the west of the pulpit . In 1758 this table pew belonged to

sherriff clerk William Davidson. And it seems that the Davidsons were fond of it as the remaining table pew is also older than the others on the ground floor.

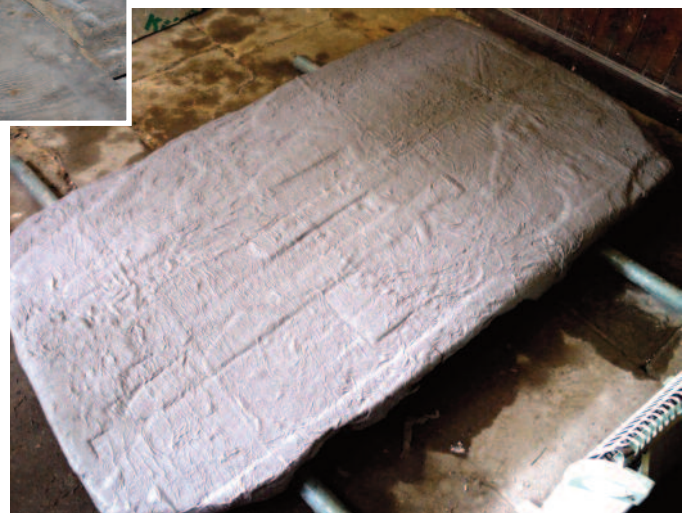
Stone conservator Karolina Kubisz has begun work on the Medieval gravestone. Found near the pulpit during work to the church around 1980, the stone has since been on display in the west porch. The work will stabilise the stone so that it lasts many more centuries. The paper poultice highlights the carvings beneath.
