# East Church Update

25 November 2009

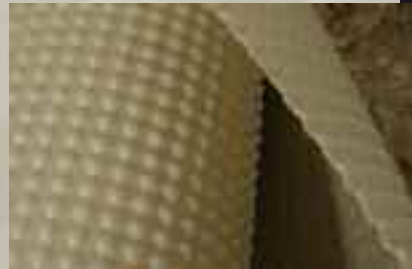
The vestry walls (above) are very wet as a result of years of leaking between it and the porch. It is thought that they could take years to dry. So the room is going to be lined with this Newton tanking, which will then be plastered over and decorated to match the rest of the church.

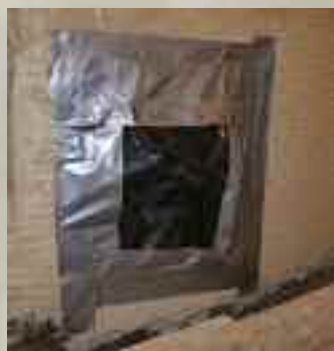
These futuristic looking patches are sealing in pieces of wood that are being used to measure damp in the building. The moisture ought to be wicking out through the walls and so the wood shouldn't be getting wet. It is looking OK so far ...
