CONSERVATION REPORT ON SANDSTONE TOMBGRAVE FROM CROMARTY EAST CHURCH

author : Karolina Kubisz

KK Art & Conservation

Elgin, October 2010

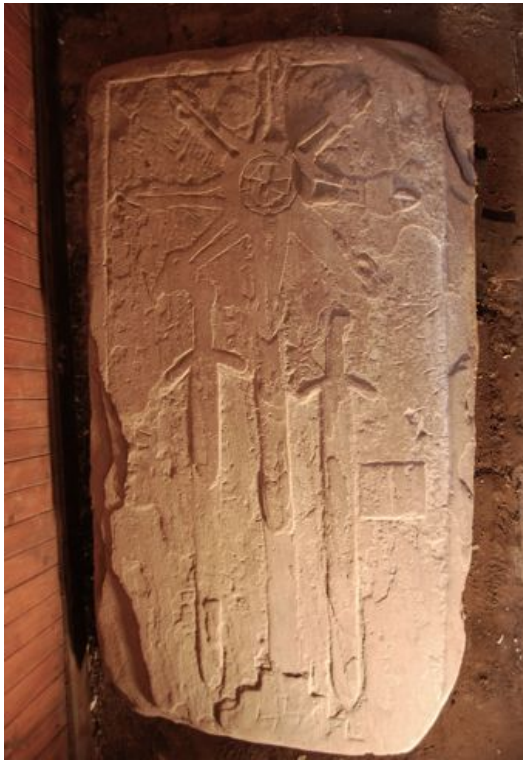
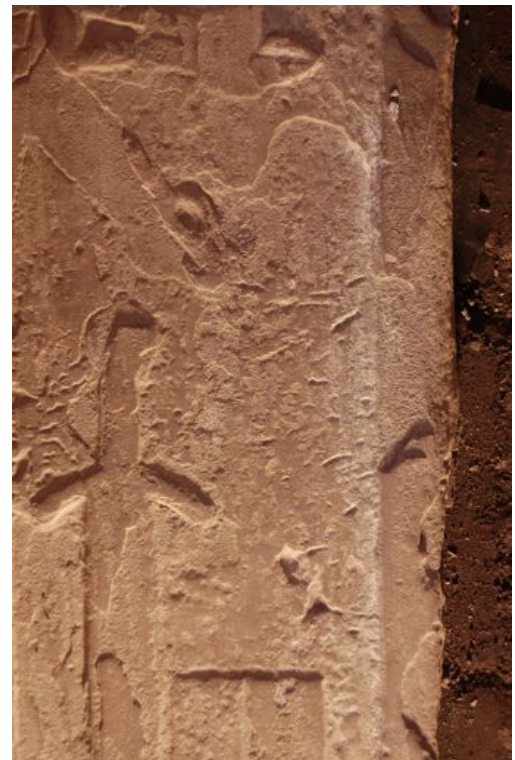
Fig.: 1-2. Tombgrave before conservation. Efflorescence (crystalised salts) is visible on the left hand side of the stone.

- nearly all original surface is lost
- stone is delaminating
- stone is splitting in many places (cracks goes through natural segmentation layers)
- large cavities (specially in the bottom left corner)
- small cavities
- most of the surface sounds hollow, but along different bed heights
- salt problems (crystallised salts are visible, specially in the upper right corner area.)
- surface is covered with dirt
- some of the stone at the bottom is missing

- salt damages, (e.g. salts are forcing layers apart) salts probably were transported with water from the ground.
- mechanical damages (people were walking on the back of the tombstone as it was used as a slab for the floor, it might be damaged while taking out of the ground)
- stone weathering
- natural property of the stone (Stone has a lot of natural segmentation layers and it's naturally weaker between the layers)

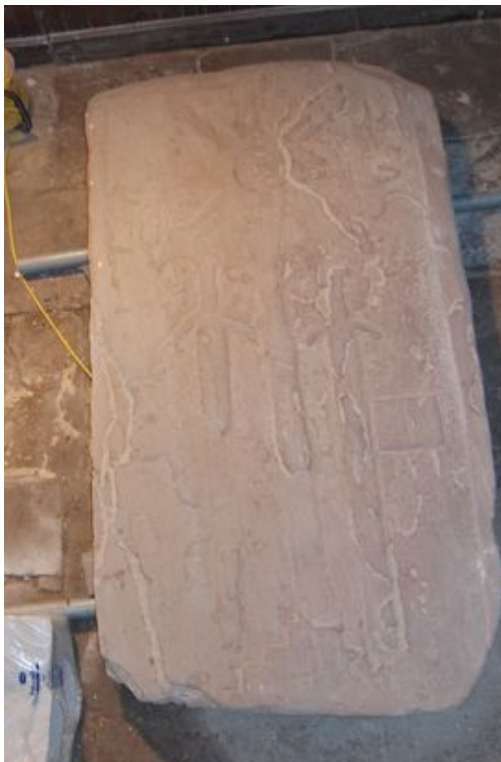
Fig.: 3. Stone after preconsolidation and temporarily mortar repairs.

1. Stone was dry cleaned using soft brushes and preconsolidated using solutions of acrylic resin- (2,5%-5% of Paraloid B72) and acrylic mortar. (No 2 in method statement)

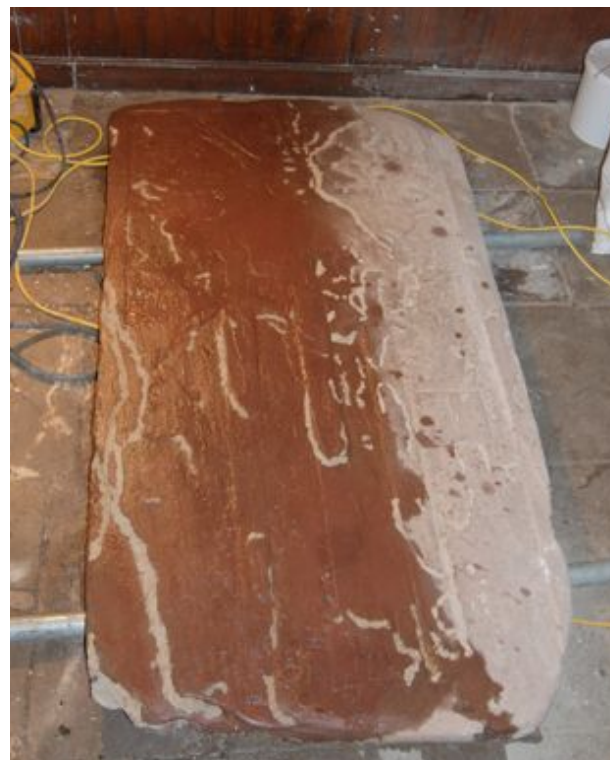
Fig.: 4. In the middle of cleaning process.

2. Stone was put on scaffold boards to provide better access.
3. Tombstone was then gently cleaned using steam cleaner and wooden tamping brushes.
4. While the stone was still wet after cleaning poultices were applied. Desalination using poultice was repeated 5 times in total.

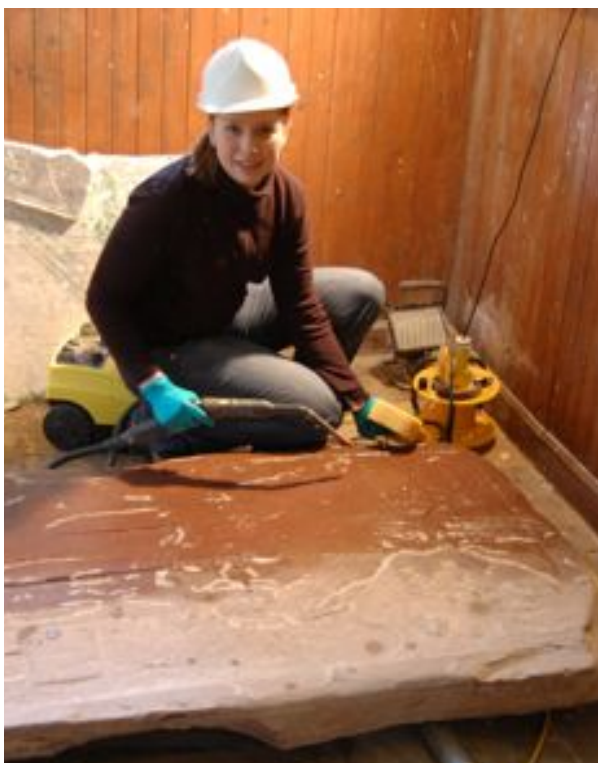
Fig.: 5 In the middle of cleaning process.

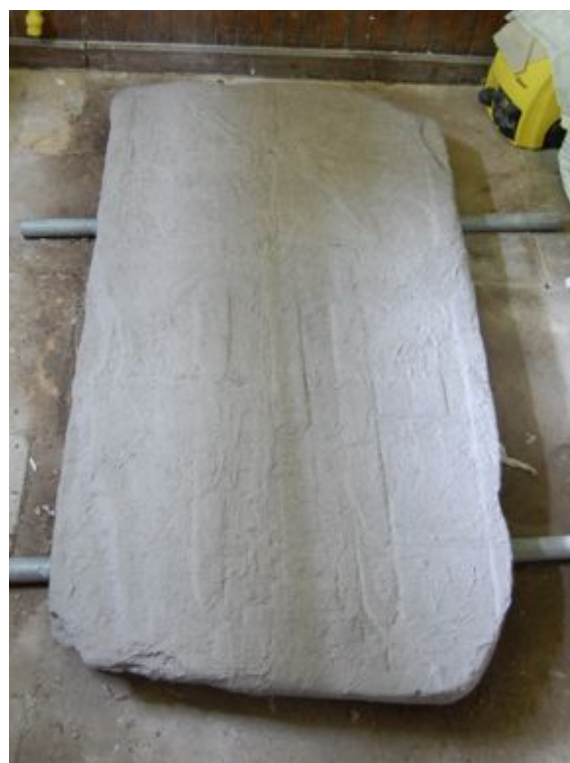
Fig.: 6. Desalination.

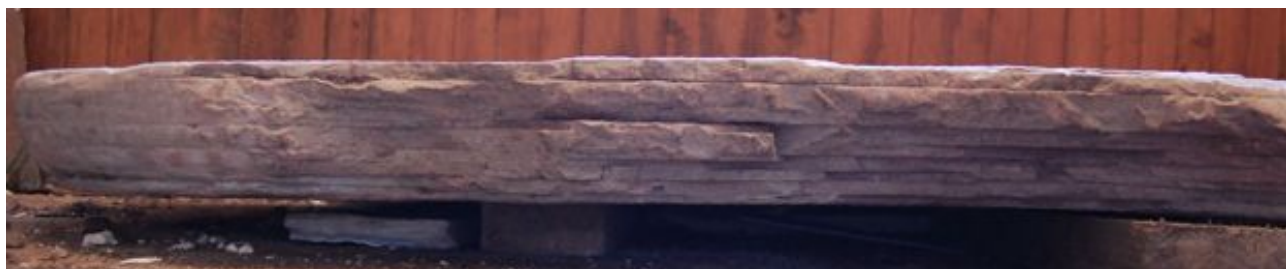
Fig.: 7. Tombgrave, detail – side view.

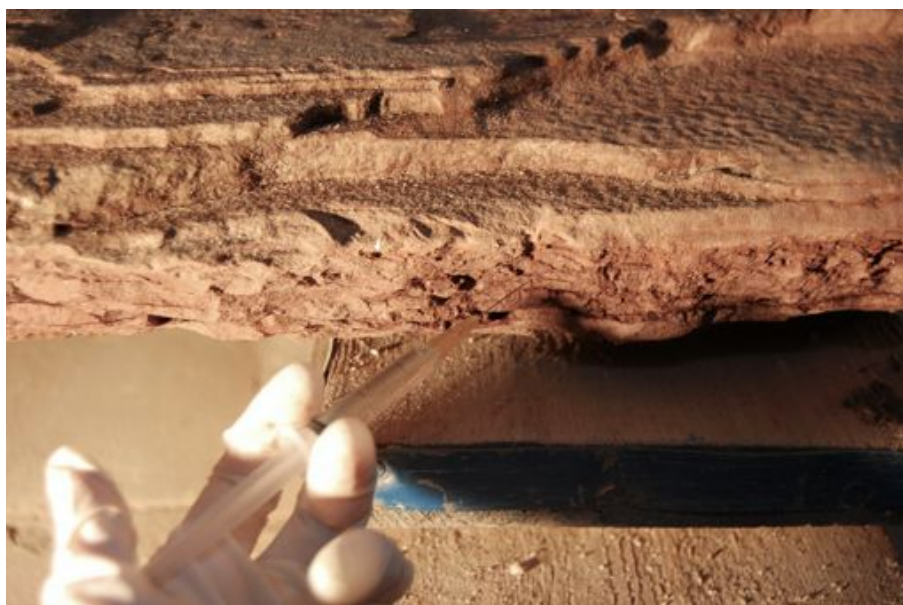
Fig.: 8. Consolidation with solutions of Paraloid B72.

5. After the stone was dry previous temporary repairs were removed with methanol (IMS) and acetone. It was decided that there was no need using a surface consolidant (silanes). Stone was consolidated locally using solutions (2,5%-10%) of acrylic resin Paraloid B72 mixed with acetone and IMS.

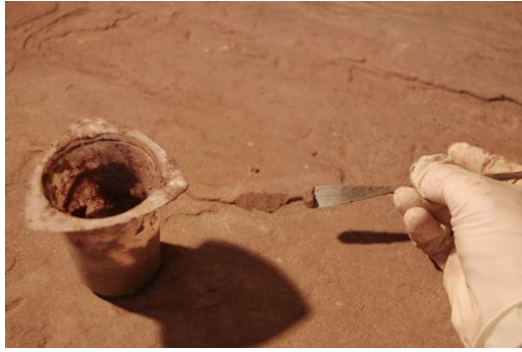
Fig.: 9. Acrylic mortar repairs.

6. At the end acrylic mortar repairs were applied to seal the cracks and edges of delaminations. For acrylic mortar repairs 10% solution of Paraloid B72 in acetone and IMS mixed with sand and pigments were used. Pigments were kept to minimum by crushing pieces of local sandstone of the same colour.

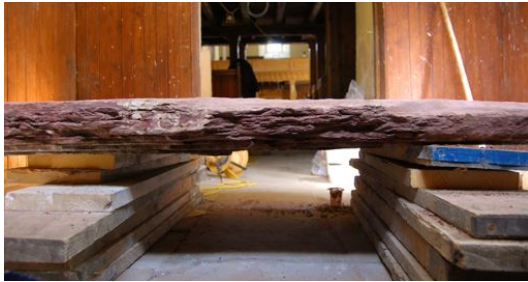
Fig.: 10. In the middle of acrylic mortar repairs.
Left hand side- after mortar repairs.
Right hand side – before repairs.

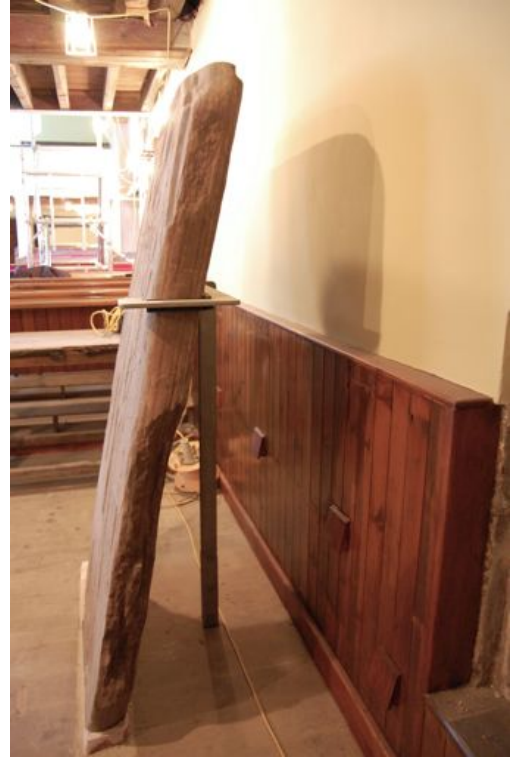
Fig.: 11. Tombgrave after conservation – side view.

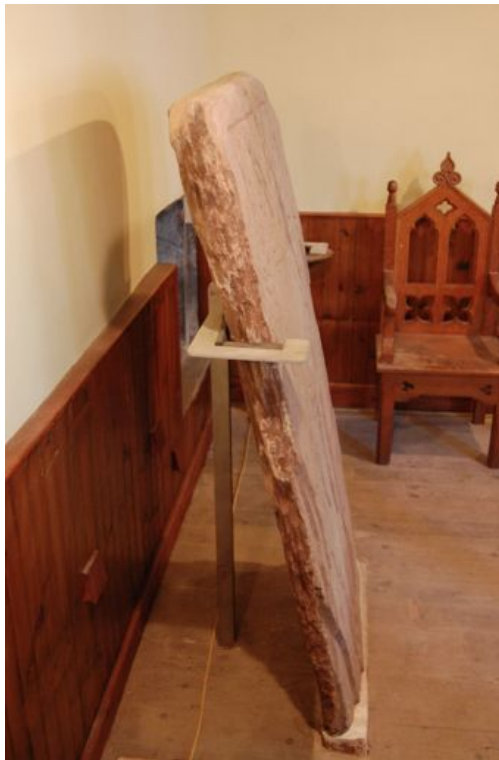
Fig.: 12. Tombgrave after conservation – side view.

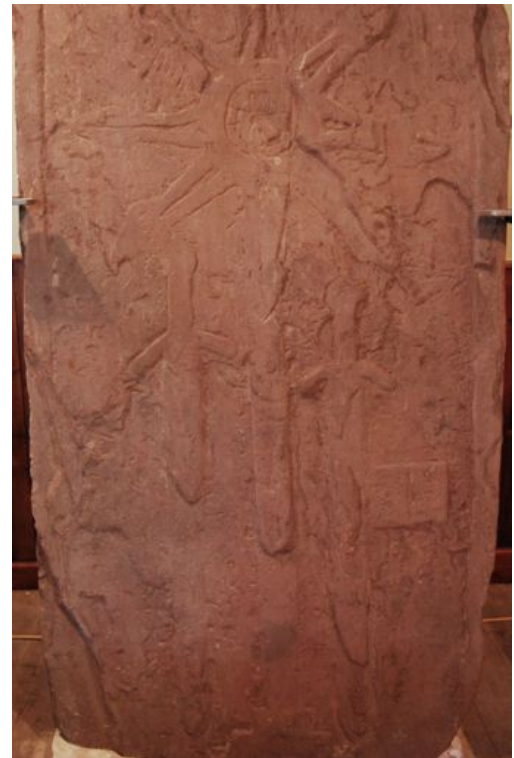
Fig.: 13. Tombgrave after conservation – detail.

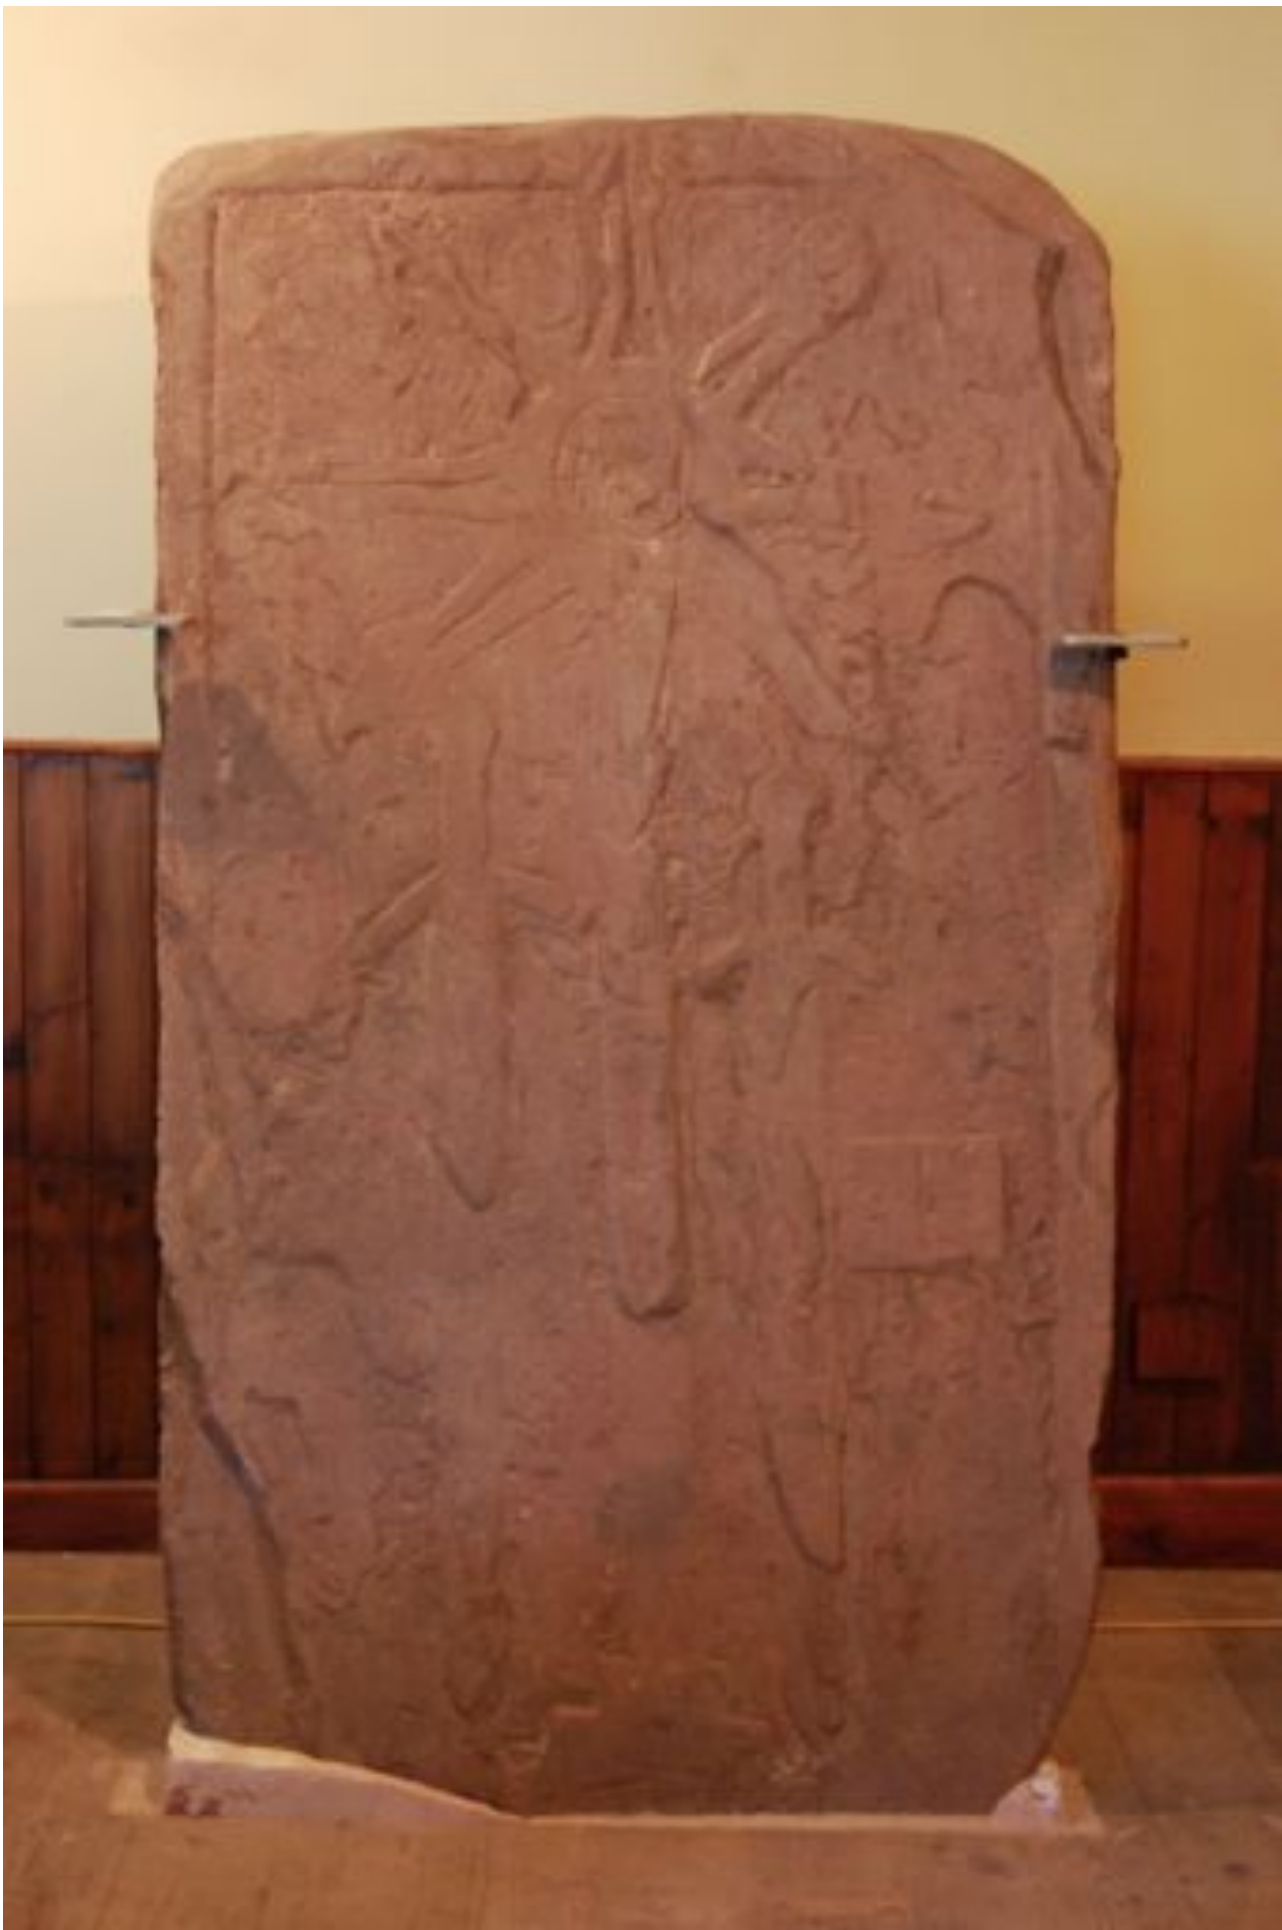
Fig.: 14. Tombgrave after conservation .

7. Then the stone was put into a specially designed display frame and rested on a base casted to shape of underneath of the stone. Base was made of polyester resin and glass fibre and then glued to the stone using Paraloid B72. Stone was protected from the raw metal with plastozote foam
