What's happening at the East Church ?

Laing Traditional Masonry Limited are the contractors who are repairing and restoring the church, and Andrew Newcombe (pictured left) is Site Manager.

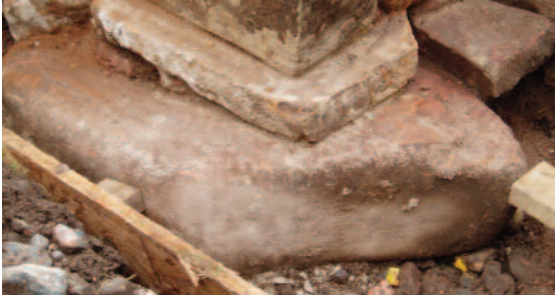
slate pinning used below window sill

Digging the drainage channels revealed the church footings . . .

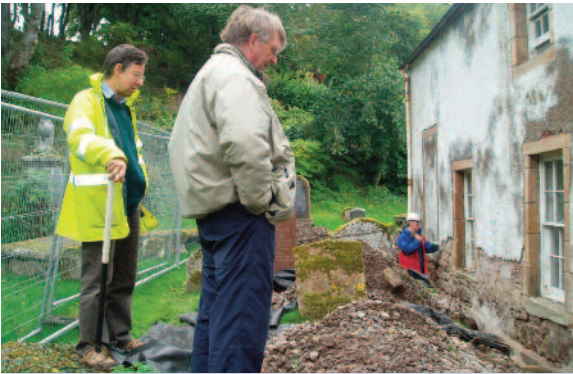
Archaeologist John Wood and David Alston contemplate the revealed stonework

. . . is this the line of a previous window?

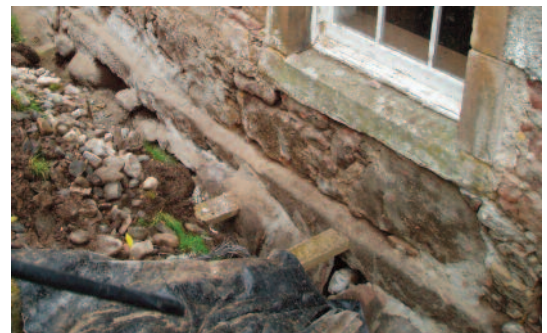
. . . why are these large flat dressed stones in the foundations, and where did they come from?

In the south wall 3 stones laid end to end measure more than 3 metres in total. In the north wall two stones – one of 1.6 metres – are placed on top of each other.
