Cromarty East Church Newsletter

Issue 6: Winter 2009/10

Work to tackle damp continues

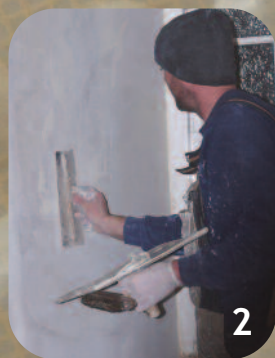
Benny and George (pic 1 - George is hiding) have given the lower edges of the roof ridge a lime mortar fillet to seal them against the slates. Lime mortar has also been applied along the edge of the skewes (also just visible in pic 1). Inside the church Andrew (pic 2) lined the very damp vestry and the cills of the two large south facing windows with Newton Tanking (the background pic) to proof against damp and then plastered over it.

Lime mortar, plaster, lime wash and guttering: all of them ingredients to reduce the damp in the church, and all have been in use over the last few months.

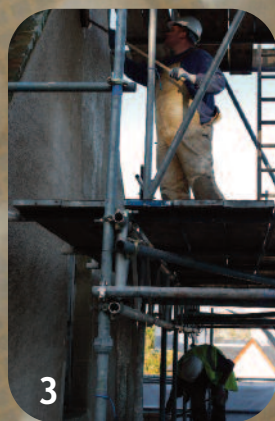
The four coats of limewash have been completed (pics 3 & 4), with a final couple of coats to be applied in late summer 2010. The colour chosen was the natural Singleton Birch, also used to harl the building.

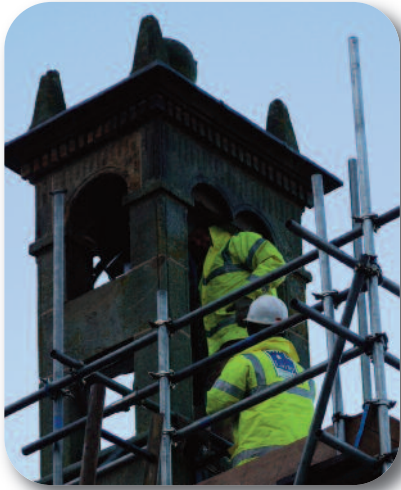
Up in the bellcote . . .

A good look at the church bell revealed that many years of ringing had unevenly worn the bell clapper, and so this was built up using steel, and a new wedge was also made for the bell to replace the old cracked one. To complete the attention to the bell, its carriage was blasted clean using aluminium oxides and then protected using some black oxide.

To give a strong supporting structure for the bell, and to protect the more delicate stonework of the cote, a steel frame was made. This was fixed to the masonry using stainless steel threaded bar, and then fixed into the

stonework with resin. This means that the load for the bell is now taken from the more heavy duty masonry directly below the tower.

Some repairs have been carried out to the East Church bell and its cote in order to make sure that they are in prime ringing condition for many years to come.

Work completed, it was then just a matter of giving the bell mechanism a good greasing and it was ready for Hogmanay action (see below). Andy was so pleased with the result that he even adopted the tower as an office ... the lengths you have to go to for mobile phone reception in Cromarty!
