Flushing out at the East Church

21 May 2009

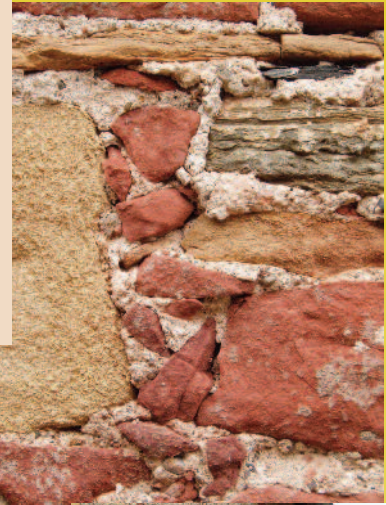
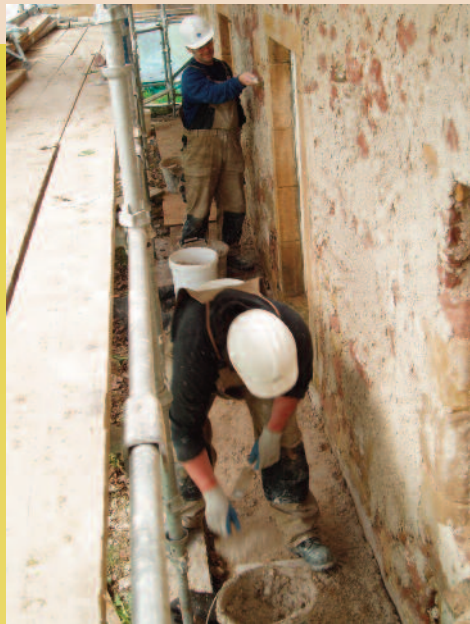
Before this goes on any gaps in the masonry are filled in using small stones and lime mortar. This is called pinning (right) and can be seen in many of Cromarty's buildings.

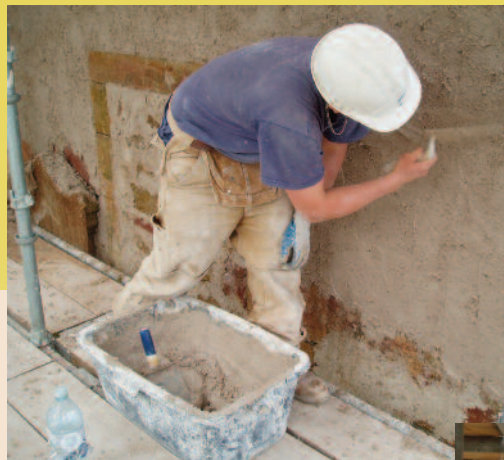
Benny and Finton are carrying out this work on the south wall

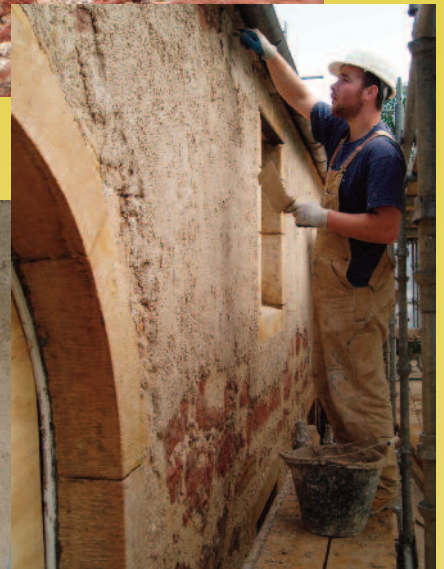
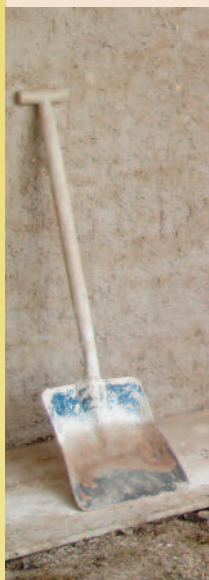
From top to bottom (right) you can see Shaun, Greg and George applying the flushing out coat of harl to the upper south wall.

The harl is applied to just barely cover the most prominent stones - giving a flush wall. This layer is left with a rough textured finish to provide a strong bond for the following coat.

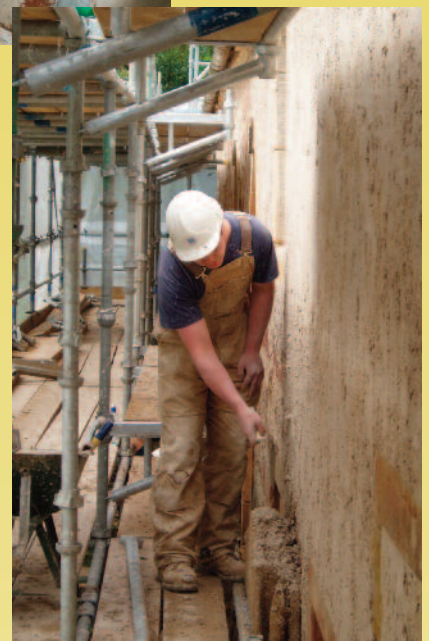
To be durable the lime must dry slowly, and so is draped with awning to trap the moisture. On warm dry days the team will also have to water the harl.
