What's happened to the wall?

East Church

25 January 2010

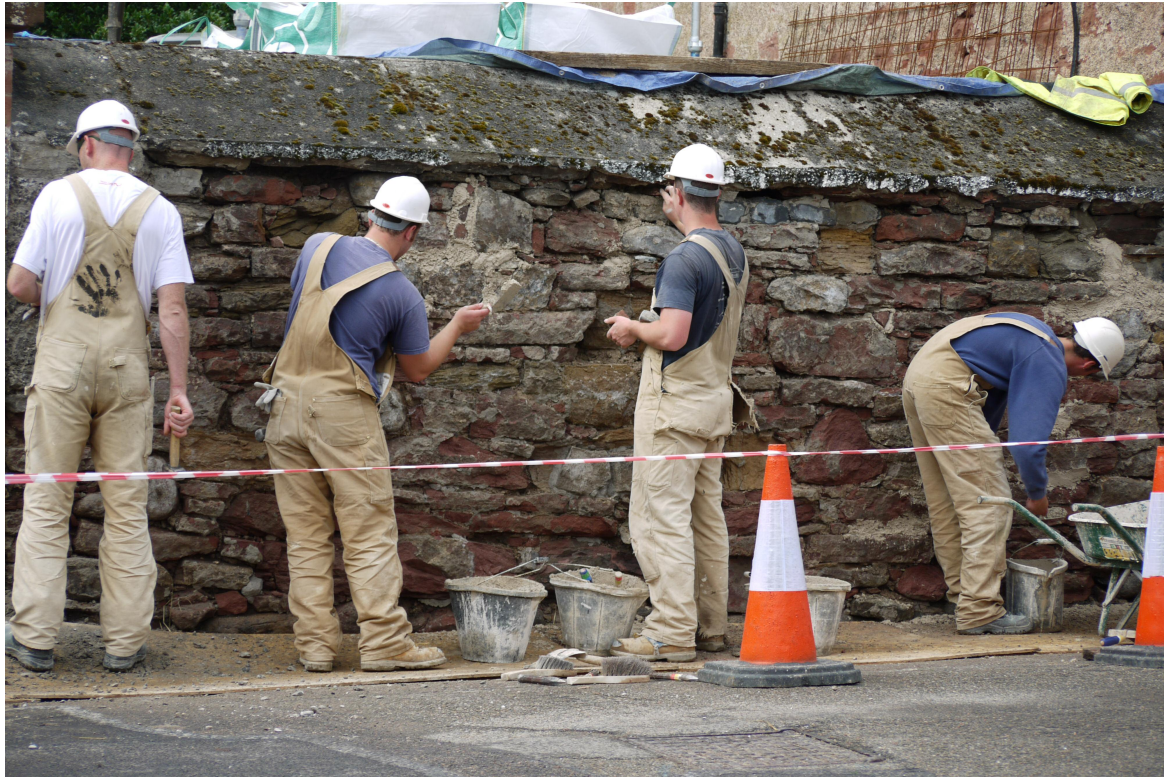
Sadly all the hard work by Laing Traditional Masonry in repairing and harling the boundary wall has been defeated by the weather.

Decades of encasement in concrete has left the wall very damp, and this has been made worse by a November that was nearly twice as wet as usual. As if that wasn't enough for the harl to deal with, we then had the longest run of days below freezing in 40 years. The usual protective hessian was no match for these forces of nature and the harl has just crumbled away.

The wall's still frozen, so no attempt at repair will be made until the weather holds above 5°C for at least a couple of weeks.

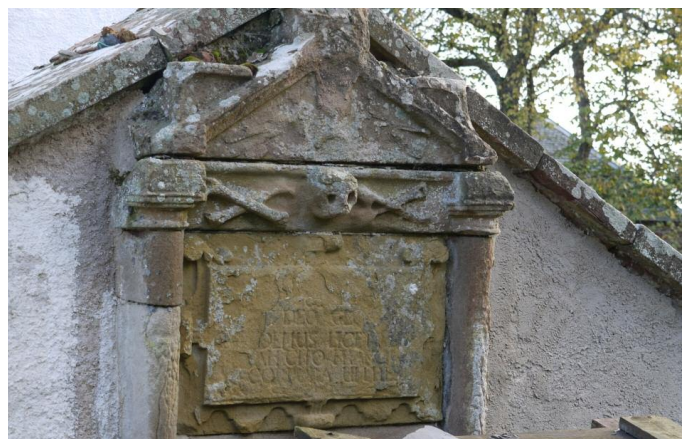
So in the meantime you might be interested to see that the high part of the wall is different stonework, suggesting that the memorial must have once stood alone.
