# East Church – Moving to new heights

23 January 2009

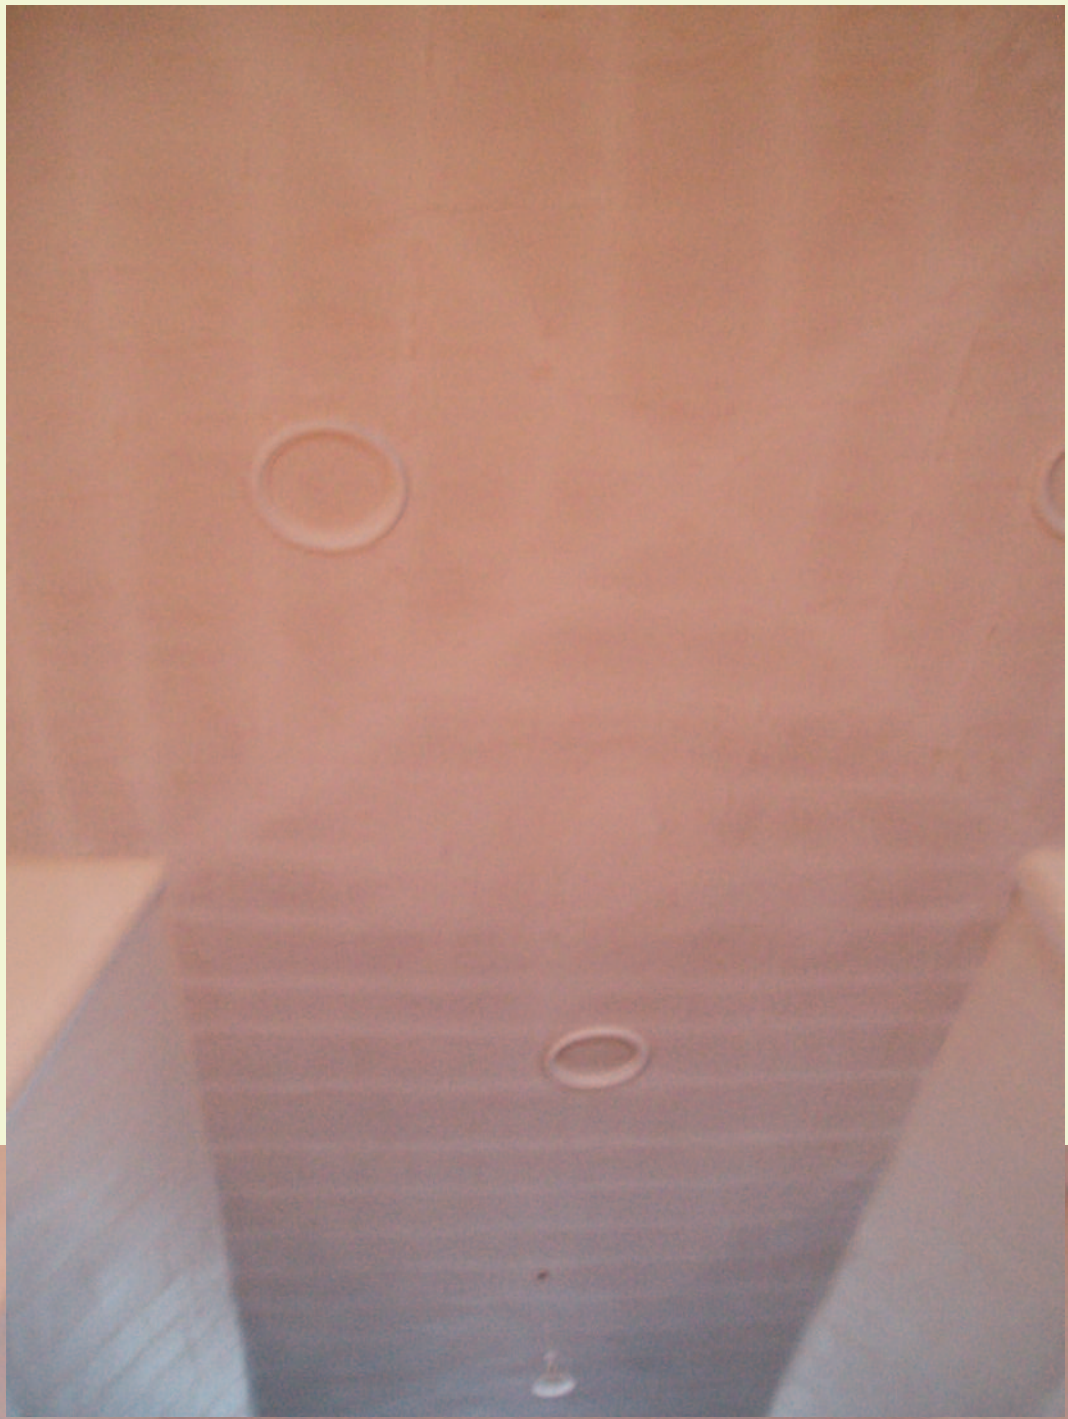
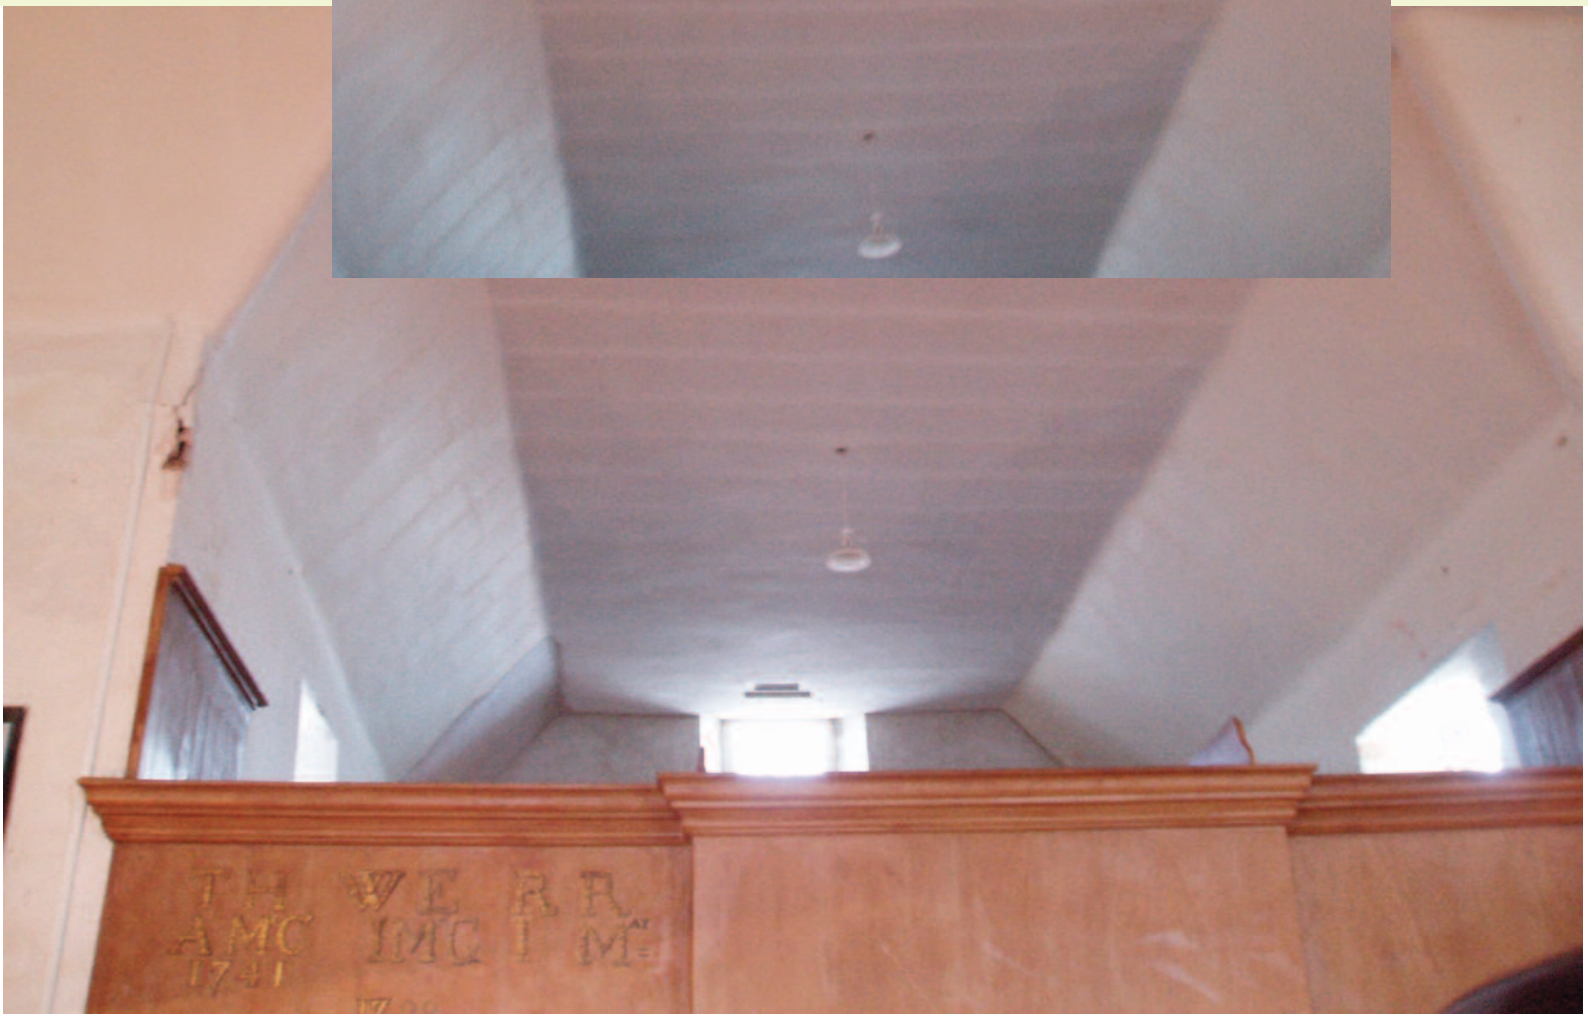
The cold  
frosty  
morning  
revealed  
lines of the  
timber  
joists in the  
ceiling  
plasterwork

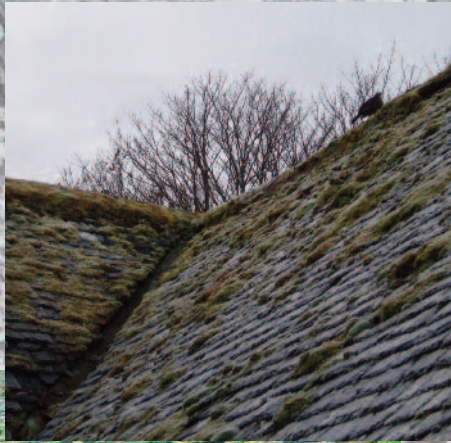
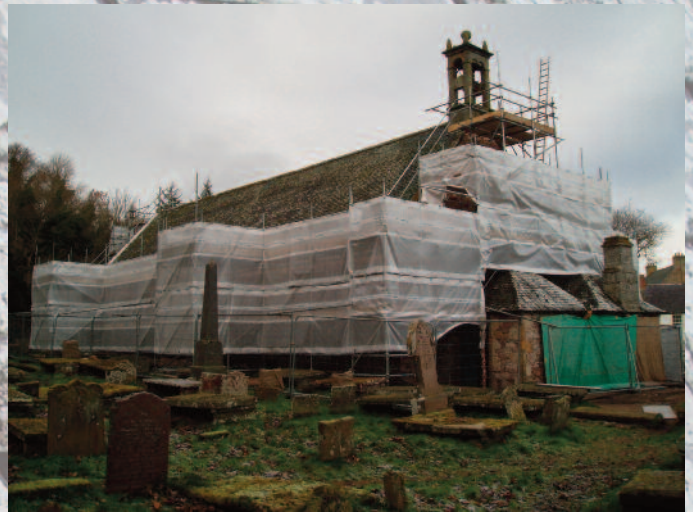
A close look at the church roof reveals the cause of some of the problems. Gutters and valleys are filled with debris, preventing them from draining properly, so that rainwater runs down the walls adding to the dampness in the church.

The moss and stonecrop clumps look beautiful but add to the build up in the gutters as they slide off the roof. Regular maintenance is the simplest solution.

The lichens however are pure asset!
