# East Church – Floor Moves

5 February 2009

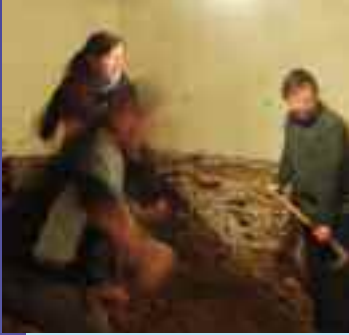
Highland Archaeology Services have finished off their work inside the

church, including making a detailed drawing of the Medieval carved stone found as part of the pre-Reformation Catholic altar kerb.

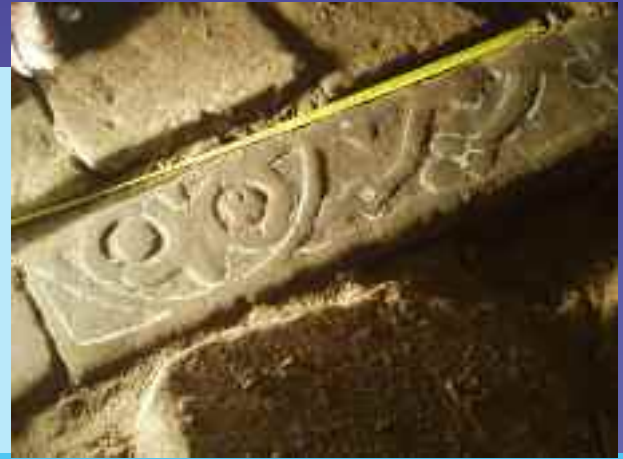
Because this is such an important part of the church's history the kerb will remain in place.

The flooring will have to cover over the kerb, but its position will be marked by a wooden carving of the stone.

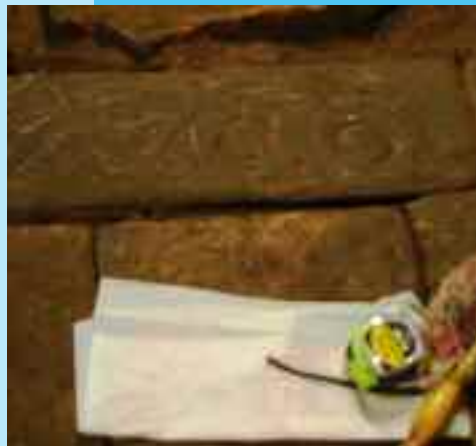
Arriving at a final decision about the best flooring to go under the wooden pew flooring has been a difficult decision for all those involved in the work at the church.

In order to protect the archaeology and provide a stable base for the scaffolding that is needed to reach to the ceiling heights, the archaeology is covered first with sand, then a geotextile membrane. On to this the soil taken out of the church during excavation is put in order

to bring the floor up to the right level for the final layer. This is a shallow concrete screed worked onto a metal grill.

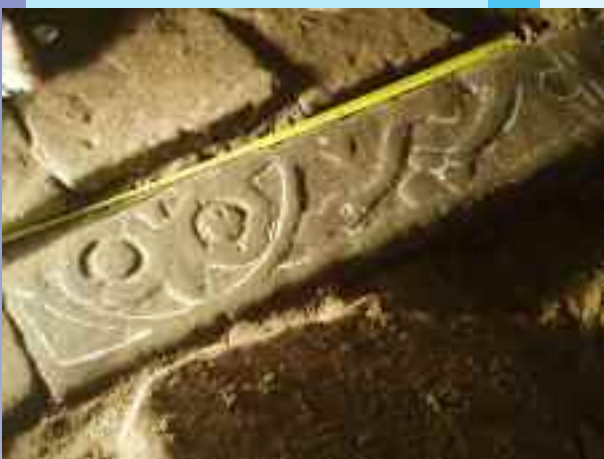
This may seem contrary to the principles of the church restoration, which is to remove the concrete harl and gypsum plasterwork in order to allow the church to breathe better, but other techniques would have damaged the valuable archaeology.

The concrete will be easy to cut through if future excavations take place, and will fall short of all the outer walls in order to allow damp to escape from the church.
