East Church: Watertight for winter

29 September 2009

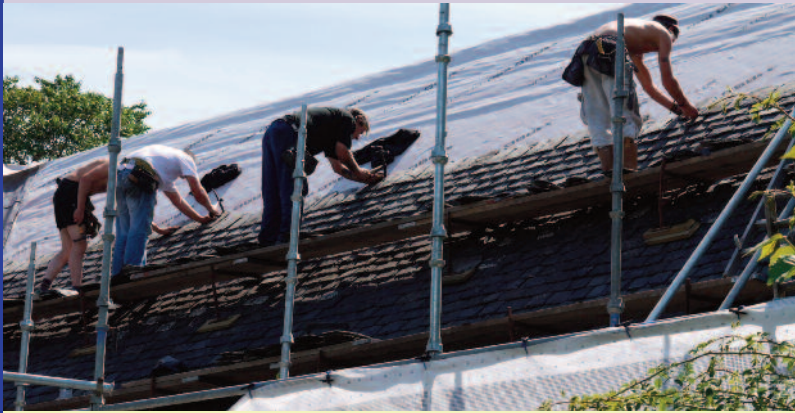
The re-slating of the roof is completed and the Ballachulish slates look a treat. Now there's just the stone ridges to go on to finish the work. These will be a mixture from the church, from

the barn that provided the slates, and new ridge stones to match the old. Keep an eye on the roof tops to see if you can spot the difference...

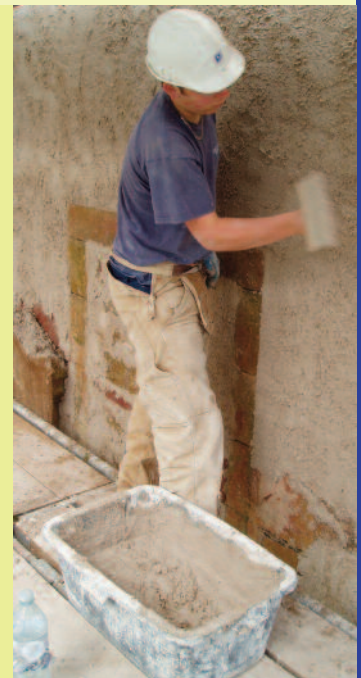
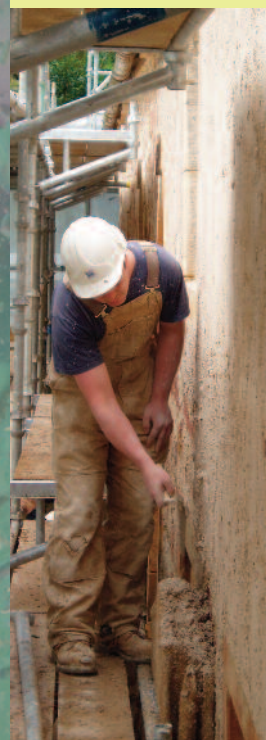
The second coat of lime harl is nearly complete, just several coats of lime wash to go now -

and then the scaffolding can come down - to reveal the exterior in all its glory.
